SHWE TAUNG CEMENT COMPANY LIMITED

Bi-Annual Environmental Monitoring Report

Biannual Environmental Monitoring Report (November 2023 to April 2024)

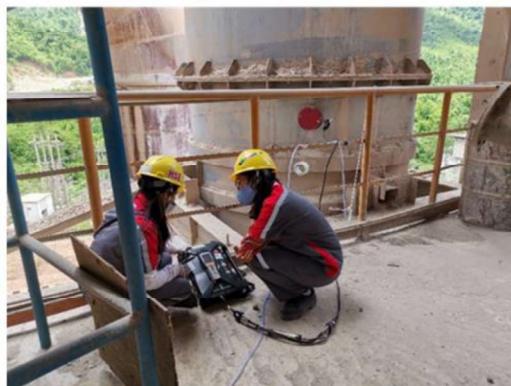
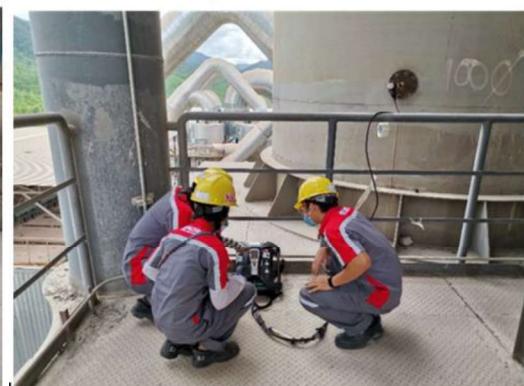
Figure – 3: Location of Kiln Stack Emission Monitoring

Line 1, Kiln Stack

Line 2, Kiln Stack

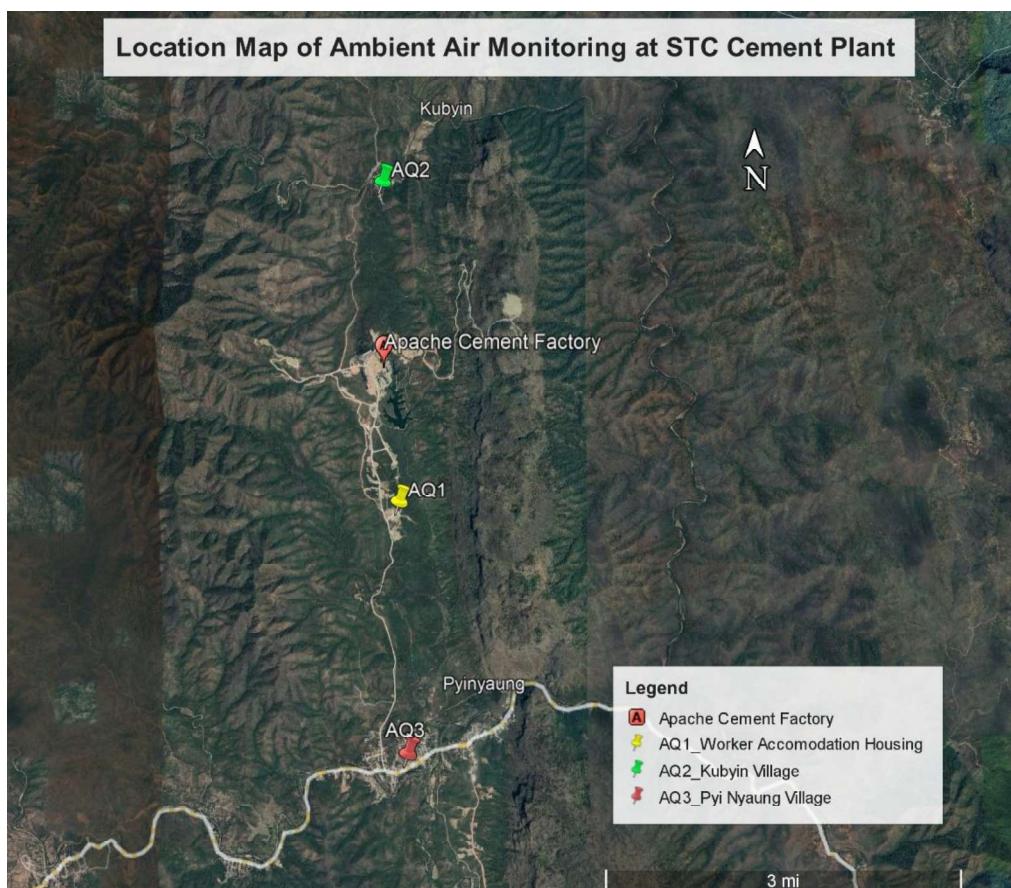
Figure – 4: Location Map of Ambient Air Monitoring at STC Cement Plant

Ambient air quality monitoring location had been selected by identifying potentially affected with consideration given to the prevailing wind conditions through Operation and Construction activities.

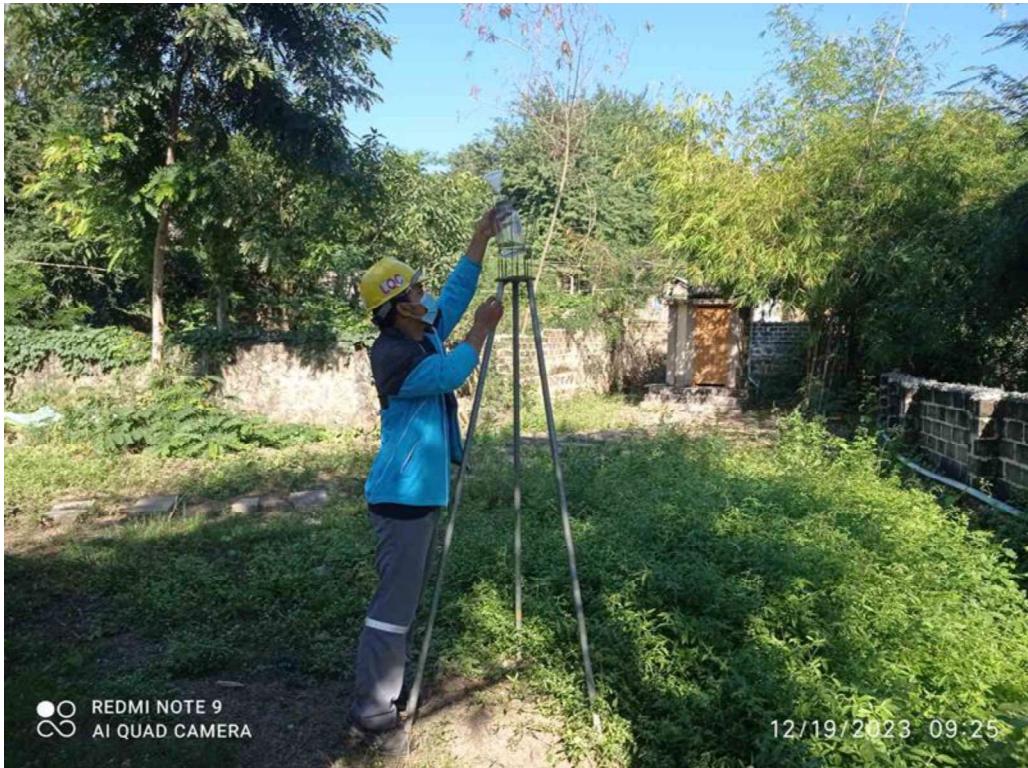
Figure – 6: Dust Deposition Monitoring

STC monitored dust deposition with 15 points at cement plant and limestone quarry, cement plant housing/ accommodation area, Ku Pyin and Pyi Nyaung village. The use of fabric/bag filter system and electrostatic precipitator to collect and control fine suspended particulate emissions are implemented in both lines of cement plant. Water suppression was also undertaken on the roads by using the water from sedimentation ponds to mitigate dust emission on surrounding area in plant site, quarries and plant accommodation area.

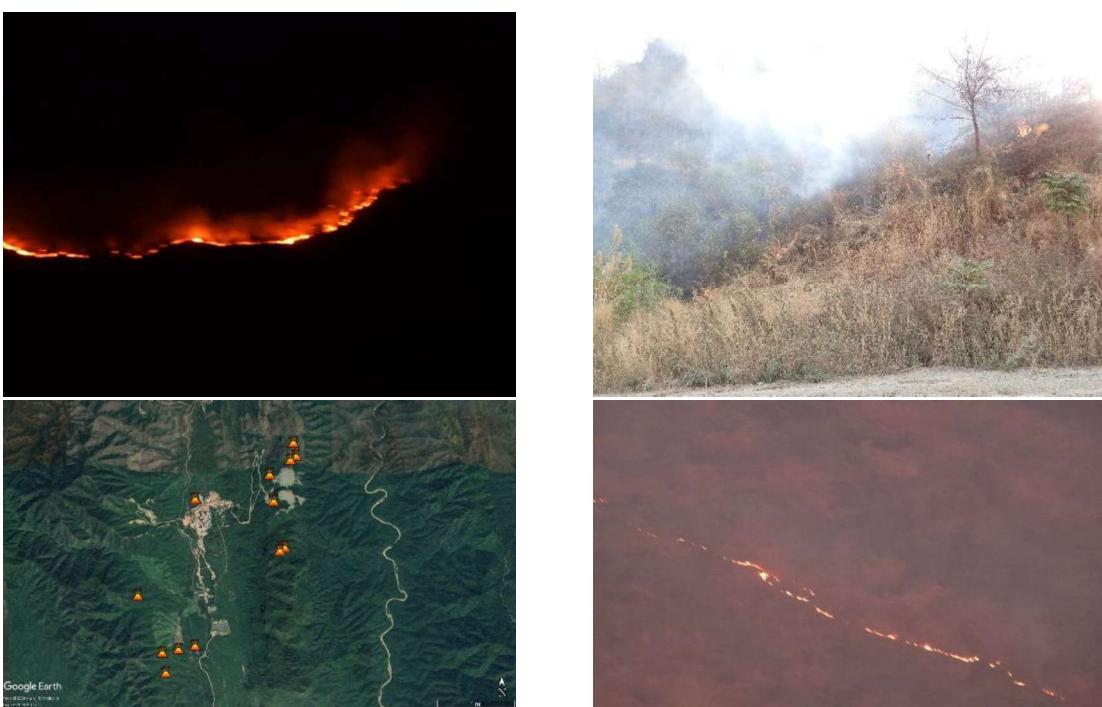
Figure – 7: Forest Fire affected the Ambient Air Quality around STC Cement Plant

By analyzing all the AQI results, it is noted that PM2.5 values are majorly impacted by human activities (forest firing & open burning, etc.) from surrounding environment. STC will raise the public awareness among cement plant community and also disclosed these air quality monitoring results and AQI results at Pyi Nyaung Information Center and Ku Pyin library according to STC Stakeholder Engagement Plan.

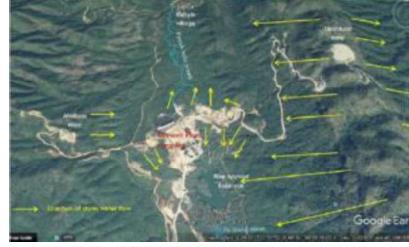
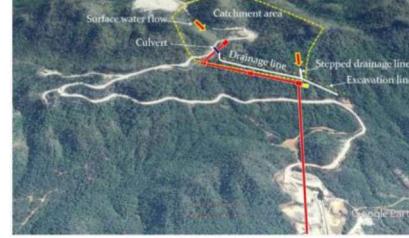
Affected Aspect	Mitigation Measures	Action Taken	Photos
Surface Water Quality	<ul style="list-style-type: none"> Implementing storm water management practices to manage the flow of storm-water, prevent uncontrolled migration and minimize erosion and sediment transport from project facilities and disturbed areas. Construction of a dedicated drainage network to intercept and diversion runoff; 	Constructed stormwater drains around the cement plant channel to sedimentation ponds

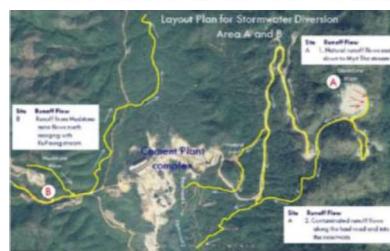
<ul style="list-style-type: none"> Divert runoff from the mudstone quarry to an appropriately sized and maintained sedimentation pond to allow adequate retention time for suspended solids to settle; 	Constructed sedimentation pond dual stage.

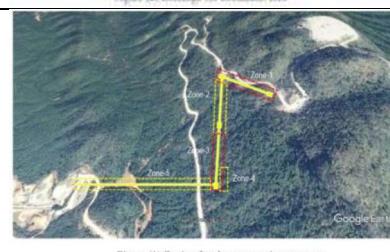
<ul style="list-style-type: none"> Baffles or other measures to reduce the velocity of runoff downhill slopes should be installed to minimize scouring; 	Visual monitoring by MNE

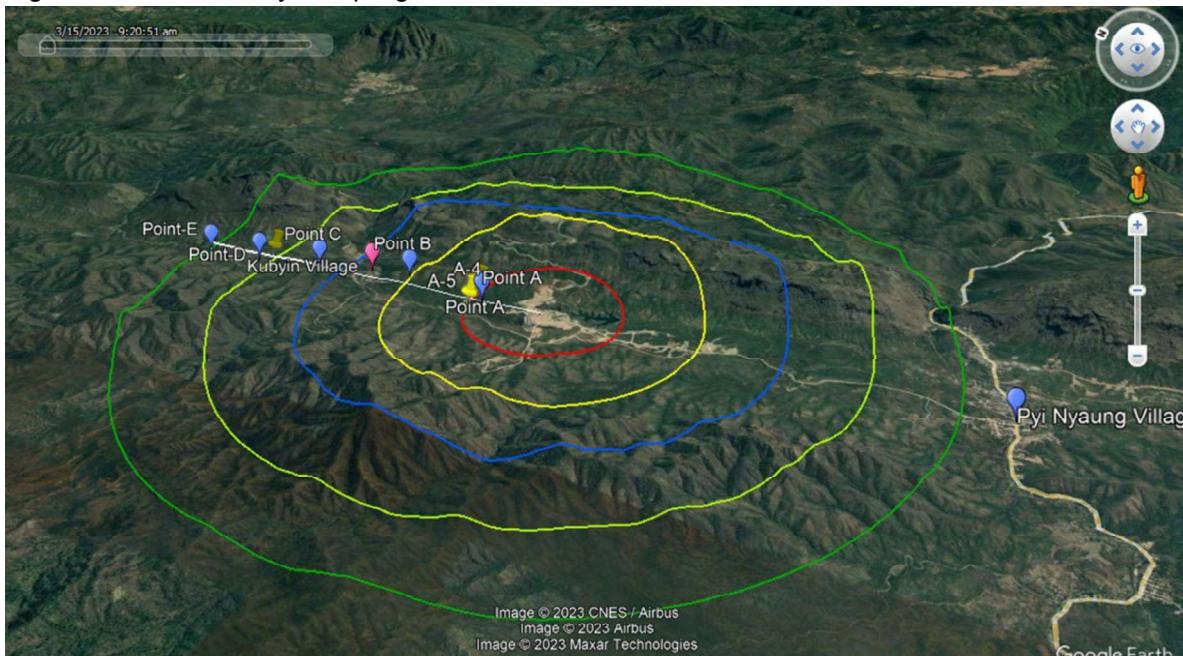
Figure – 11: Soil Quality Sampling Points

Soil quality monitoring was undertaken in April 2023 in Ku Pyin village. The locations for soil sampling are provided in Figure 12. Two soil samples were taken at each sampling location. These samples were sent to the laboratory analyzed by Department of Agriculture (Land Use), Ministry of Agriculture, Livestock and Irrigation (MOALI). Parameters measured included Moisture, pH, Electrical Conductivity, Organic Carbon, Humus, Total Nitrogen, Ca^{2+} , Mg^{2+} , K^+ , P, K_2O , Water Soluble SO_4^{2-} . Soil quality monitoring results for laboratory analyzed parameters are shown in Table 5.

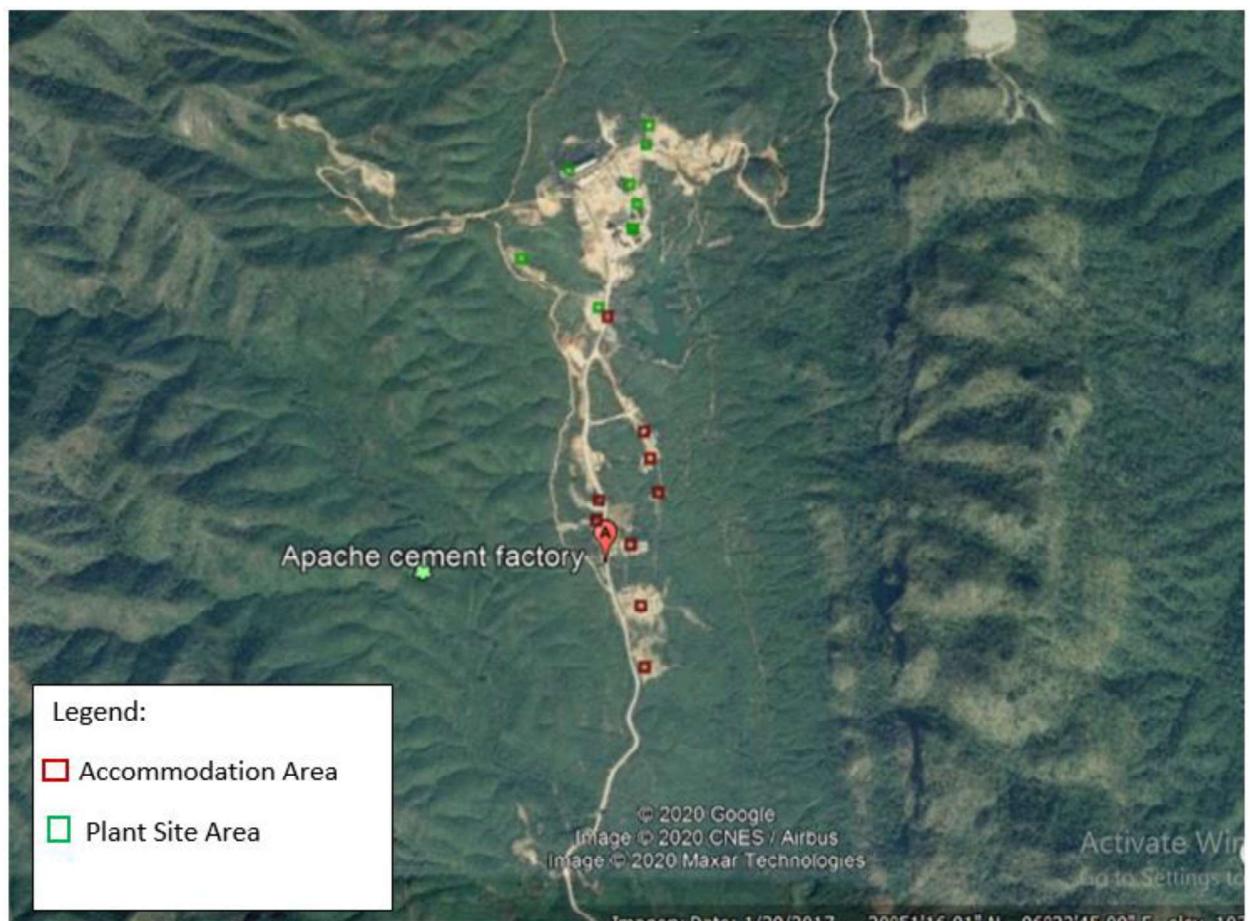
Figure – 12: Location Map of Collection Points of All Generated Wastes from Plant Site and Accommodation Area

In Shwe Taung Cement Factory, collect non-hazardous waste generated from plant site and accommodation area every day and dispose them to Temporary Non-hazardous Storage Area. For kitchen wastes, compost or use as animal feed in nearby villages. On the other hand, dispose laboratory and clinical wastes to Meikhtila Incinerator, Meikhtila District, Mandalay Region, approved by Meikhtila City Development Committee and have plan to dispose hazardous wastes to Golden Dowa Eco-system Myanmar Co., Ltd., Accredited Waste Management Company. Figure 12, 13 and 14 shows location maps of waste disposal area and waste collection points.

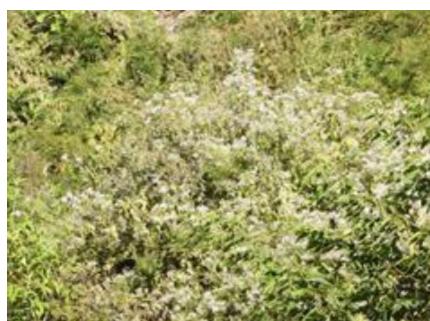
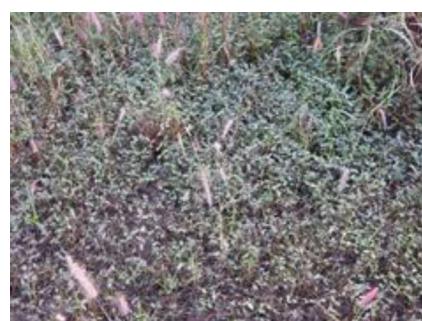
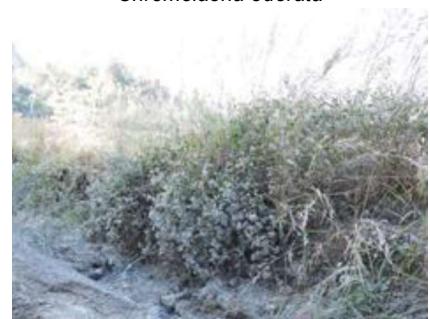
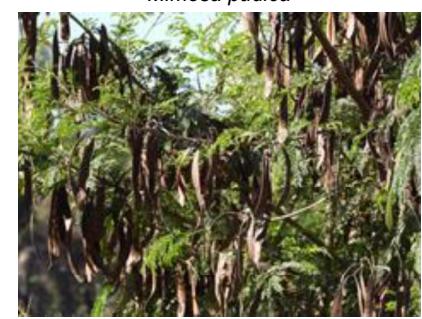
Figure – 15: Invasive Species Survey

Chromolaena odorata

Mimosa pudica

Leucaena leucocephala

These dominant species mostly found cement plant and should control in time. *Mimosa pudica* (Htikayone) should collect and burned to control distribution. *Leucaena leucocephala*, (Bawsakaing) should cut the tree before fruiting season and dig the root to stop coppicing. *Chromolaena odorata* (Bizat) should cut the bushes and burn before flowering season. They can reproduce especially in wind dispersal methods and sometime by animals and trucks. Detail survey will make in quarterly to monitor the distribution of invasive species. We should also use herbicide to control some invasive species.

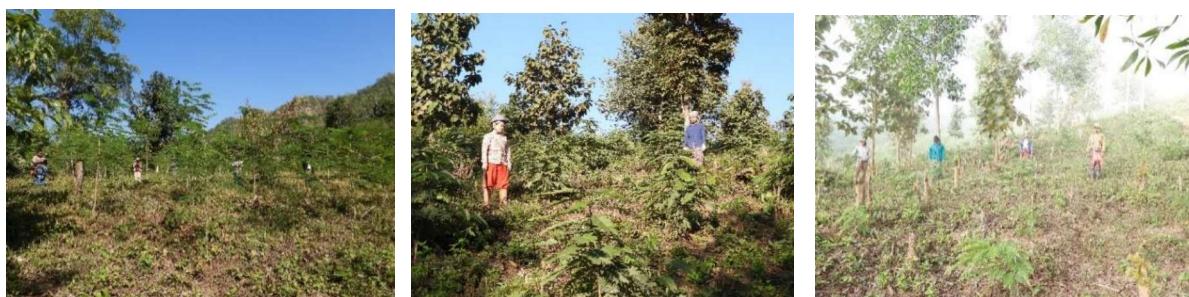
Figure – 16: Patching Process at Ecosystem Restoration Plantation

STC took zero burning practice in all plantation to protect carbon emission from our activities. It may lead to develop slow growth of some species such as Kyun and Myanmar Kokko. The grow rate of Sein Pan is the best growth rate that average is about 7 ft in South Pyi Nyaung plantation. Mazili grow rate is the best in plantation 65 acre near cement plant. Padauk was damage due to domestic buffalo from near village. STC will mitigate to get better growth rate plantation in next year by changing of planting pattern, selection of species, preparation of soil before planting.

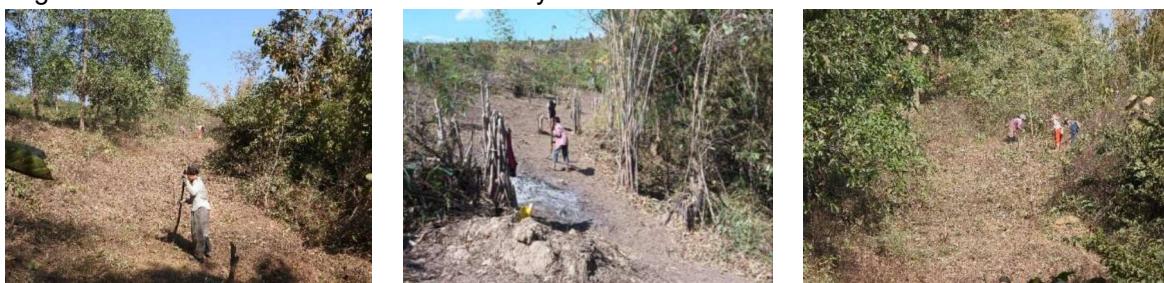
Figure – 17: Fire Protection Process at Ecosystem Restoration Plantation

STC has operated fire protection road at ecological system restoration plantation to protect forest fire in summer season. STC use local contractors to give job opportunity from our activities. Fire protection has been finished at the third week of February 2024.

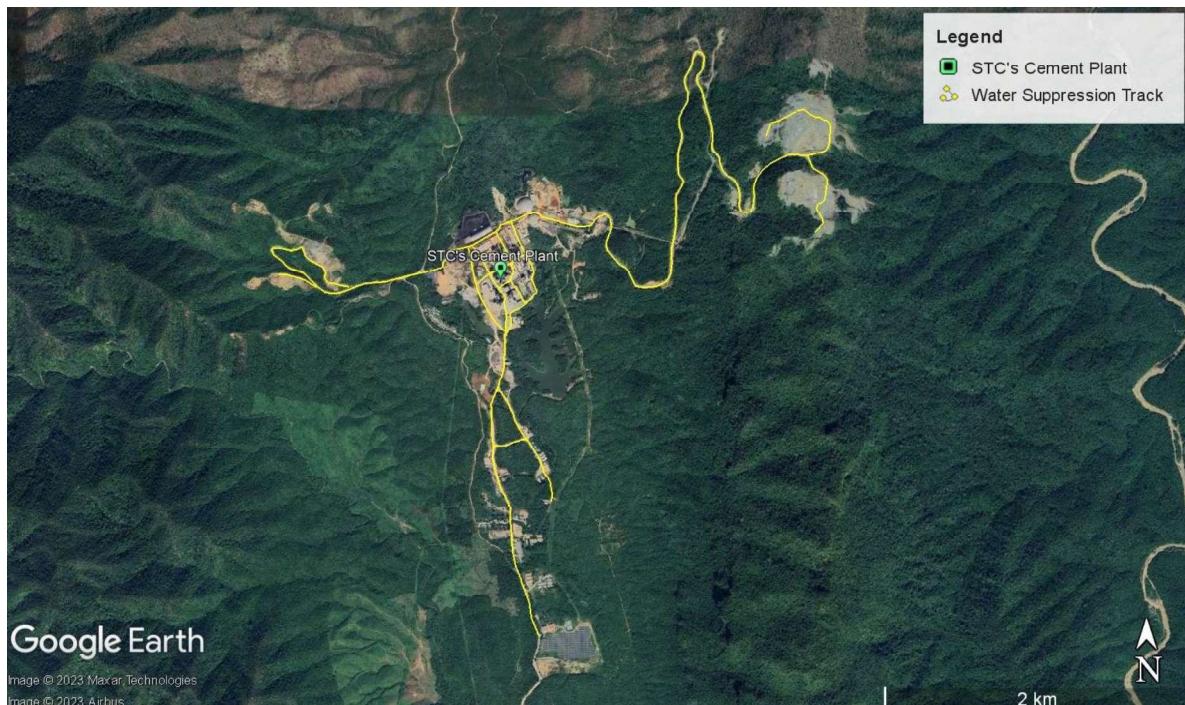
Figure: Water Suppression Map to mitigate dust emission in plant site

The use of fabric filter system and electrostatic precipitator to collect and control fine suspended particulate emissions are implemented. Water suppression are also undertaken on the roads to mitigate dust emission on surrounding area in plant site and accommodation area. (See in Appendix A)
