SHWE TAUNG CEMENT COMPANY LIMITED

Biannual Environmental Monitoring Report

(May 2024 to October 2024)

Bi-Annual Environmental Monitoring Report

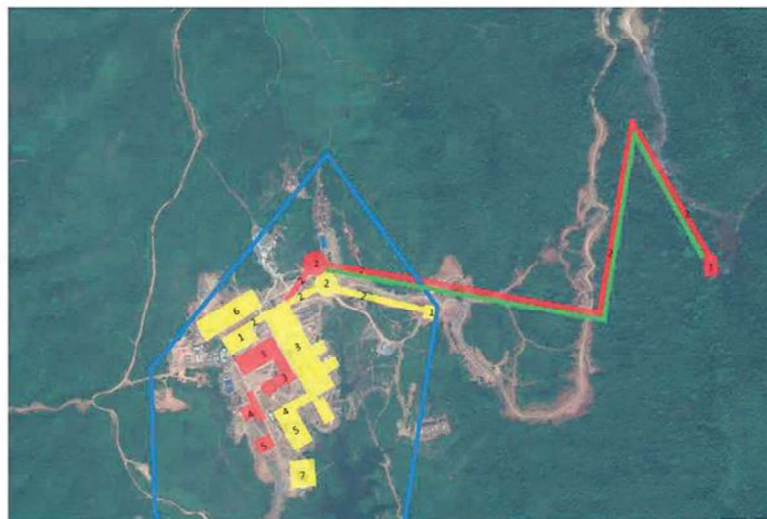
Figure – 2: Project Components of the Existing and Expanded STC Cement Plant

Existing Cement Line Facilities	 Expansion Cement Line
1 - Raw Materials Crushing Area	1 - Raw Material Crushing Area
2 - Handling Area	2 - Handling Area
3 - Clinker Production Area	3 - Clinker Production Area
4 - Cement Grinding Area	4 - Cement Grinding Area
5 - Cement Packing and Dispatch Area	5 - Cement Packing and Dispatch Area
6 - Coal Staging Area	 - Expansion Conveyor Line
7 - Office	 - Boundary Line

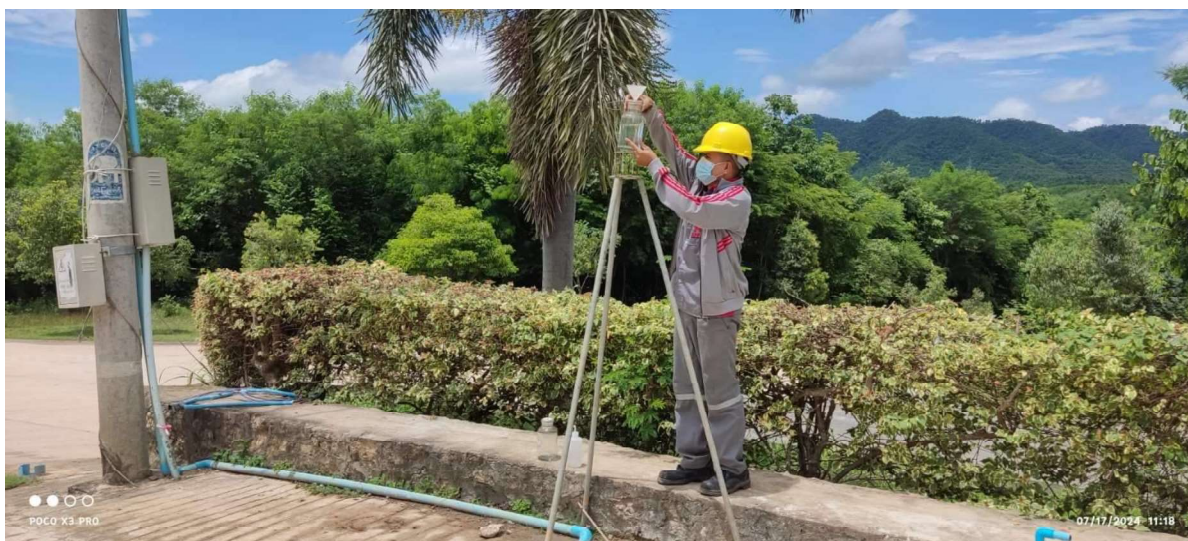
Figure – 6: Dust Deposition Monitoring

STC monitored dust deposition with 15 points at cement plant and limestone quarry, cement plant housing/ accommodation area, Ku Pyin and Pyi Nyaung village. The use of fabric/bag filter system and electrostatic precipitator to collect and control fine suspended particulate emissions are implemented in both lines of cement plant. Water suppression was also undertaken on the roads by using the water from sedimentation ponds to mitigate dust emission on surrounding area in plant site, quarries and plant accommodation area.

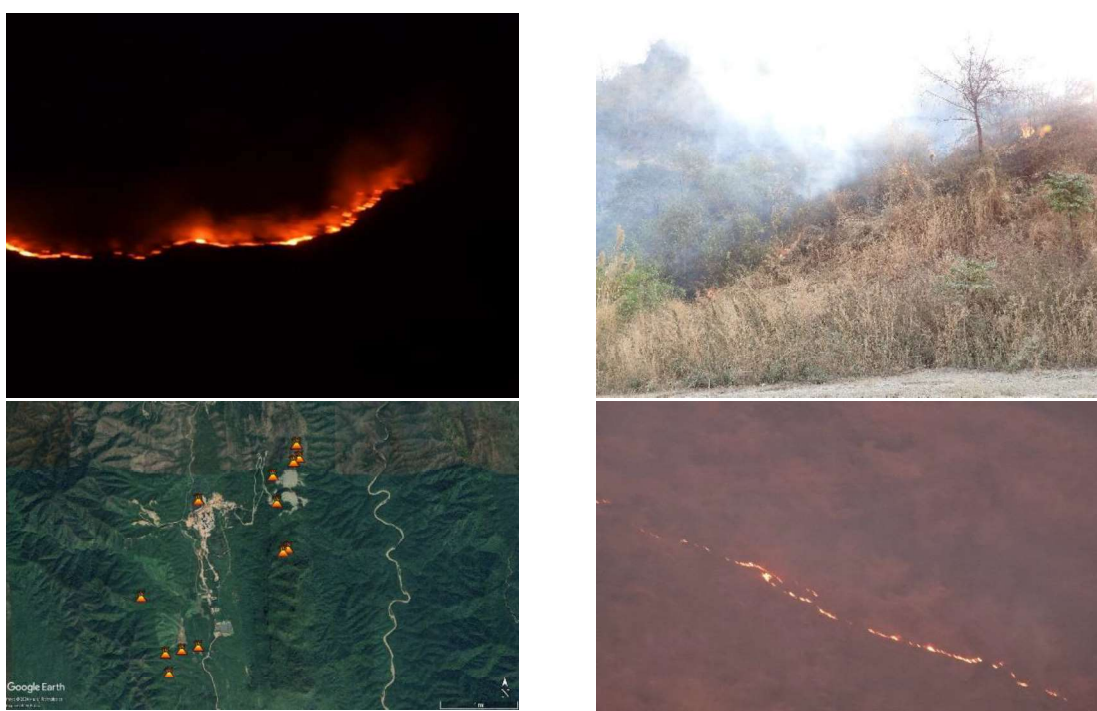
Figure – 7: Forest Fire affected the Ambient Air Quality around STC Cement Plant

By analyzing all the AQI results, it is noted that PM_{2.5} values are majorly impacted by human activities (forest firing & open burning, etc.) from surrounding environment. STC will raise the public awareness among cement plant community and also disclosed these air quality monitoring results and AQI results at Pyi Nyaung Information Center and Ku Pyin library according to STC Stakeholder Engagement Plan.

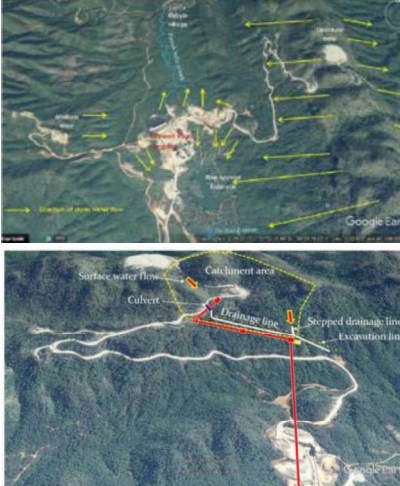
Affected Aspect	Mitigation Measures	Action Taken	Photos
Surface Water Quality	<ul style="list-style-type: none"> Implementing storm water management practices to manage the flow of storm-water, prevent uncontrolled migration and minimize erosion and sediment transport from project facilities and disturbed areas. Construction of a dedicated drainage network to intercept and diversion runoff; 	Constructed stormwater drains around the cement plant channel to sedimentation ponds

<p>Figure (2) Drainage for catchment area</p>
	<ul style="list-style-type: none"> Divert runoff from the mudstone quarry to an appropriately sized and maintained sedimentation pond to allow adequate retention time for suspended solids to settle; 	Constructed sedimentation pond dual stage.	<p>Sedimentation pond from storm water runoff to allow adequate retention time for suspended solids to settle before entering wetlands area.</p> <p>Location Map of Sedimentation Pond at STC Site</p>

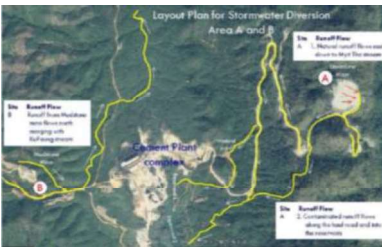
<p>Layout Plan for Stormwater Discharge Area A and B</p>

<ul style="list-style-type: none"> Divert runoff from the limestone quarry to the wetland created by STM via a weir to remove suspended solids before entering the wetland; 	Constructed sedimentation pond dual stage.

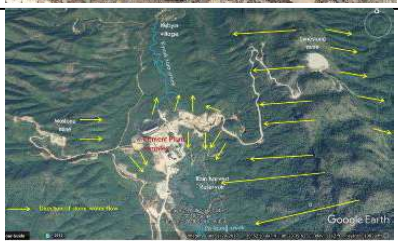
<p>Figure 3.2 Storm water flow, cement plant and limestone mine area</p>
	<ul style="list-style-type: none"> All areas used to store and/or handle coal, laterite and limestone should be paved and surrounded by perimeter drains. For the coal storage area, it should be covered; 	Implemented and covered during monsoon season	<p>Material Handling: Coal Stockpile Storage @ 501 Area</p>

<ul style="list-style-type: none"> STM will prepare and implement a Storm water Management Plan considering the mitigation committed above. 	Plan have been developed and construction on progress for Line 2 area. Line 1 area was constructed since 2014.

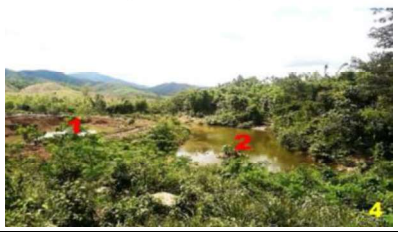
<p>Coal Staging Stockpile: Double Stage Sedimentation Pond</p>

<ul style="list-style-type: none"> Runoff from the laterite and limestone staging areas shall be diverted to retention ponds and may be used for greening, dust suppression or discharged to the onsite reservoir. 	Constructed sedimentation pond dual stage and reuse for gardening and dust control.

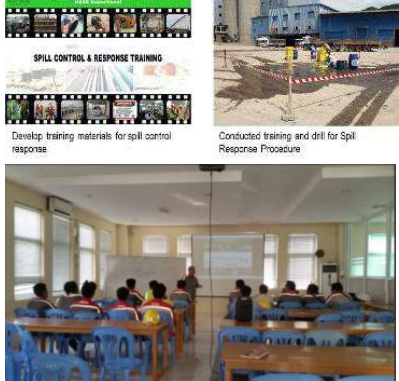
<p>Constructed bunded hardstand with containment for 110% of the volume of stored fuel and equipped with oil-water separator. Installed lightning protection post.</p>
	<ul style="list-style-type: none"> Spill Response Plan should be developed and implemented; (conducted awareness training and deliver pamphlet to relevant employees in the plant) 	Approved and implemented

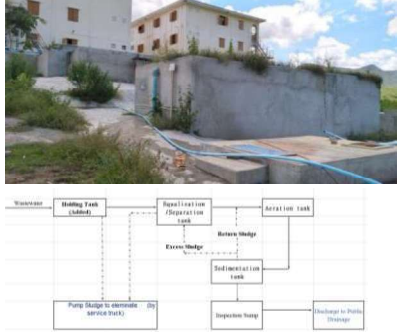
<ul style="list-style-type: none"> Sanitary wastewater (includes toilet, sink, shower) should be discharged to the wastewater treatment plant and not be directly discharged to any water bodies. Kitchen flows should be discharged for treatment at dedicated grease trap / water purification unit and not be directly discharged to any water bodies. 	Constructed Bio Tank for treatment of sanitary wastewater.

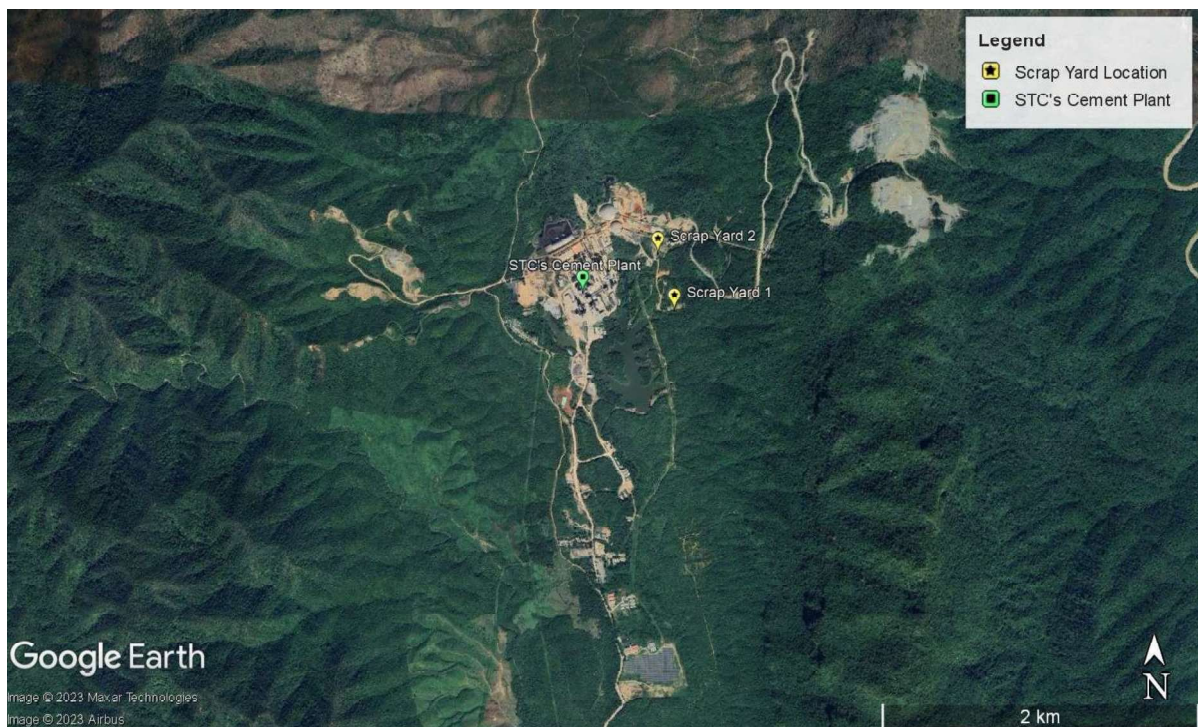
Figure – 14: Location Map of Site Waste Dumping Area (Scrap Yard)

<ul style="list-style-type: none"> Segregate wastes and recycle wherever possible; 	<p>Segregated scrap materials for resale and reuse (See Figure-13 for Scrap Yard Area)</p>

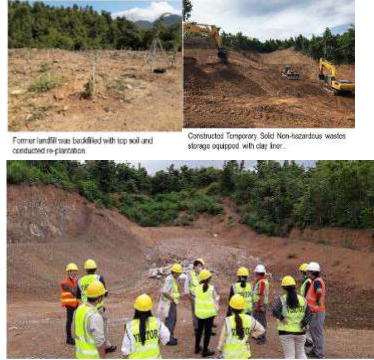
<ul style="list-style-type: none"> The existing landfill is not lined and should be only used for inert (non-reactive) and non-hazardous waste only. 	<p>Implemented</p> <p>(Constructed Old Temporary Non-hazardous solid storage area for disposing Non-hazardous waste and operated it from 2012 to June 2019. Replantation in old place after closure. After inspection of New Temporary Non-hazardous solid storage area from ECD and governmental organizations in 5 July 2019, operate that one until now.)</p>

<p>Former landfill was backfilled with top soil and conducted re-plantation.</p> <p>Constructed Temporary Solid Non-hazardous wastes storage equipped with clay liner.</p> <p>Temporary Solid Non-hazardous wastes storage inspected by ECD and other government entities for the approval of EIA.</p>

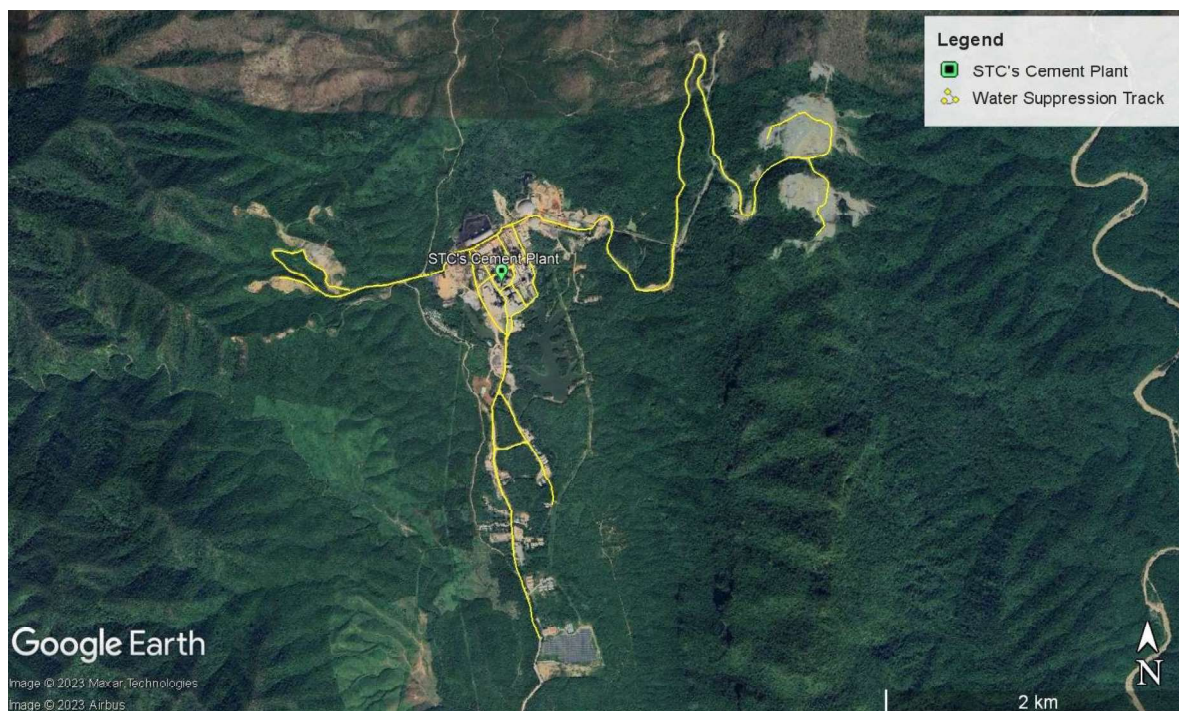
Figure: Water Suppression Map to mitigate dust emission in plant site

The use of fabric filter system and electrostatic precipitator to collect and control fine suspended particulate emissions are implemented. Water suppression are also undertaken on the roads to mitigate dust emission on surrounding area in plant site and accommodation area. (See in Appendix A)
