SHWE TAUNG MINING COMPANY LIMITED

Red Clay Quarry

Biannual Environmental Monitoring Report

(August 2024 to January 2025)

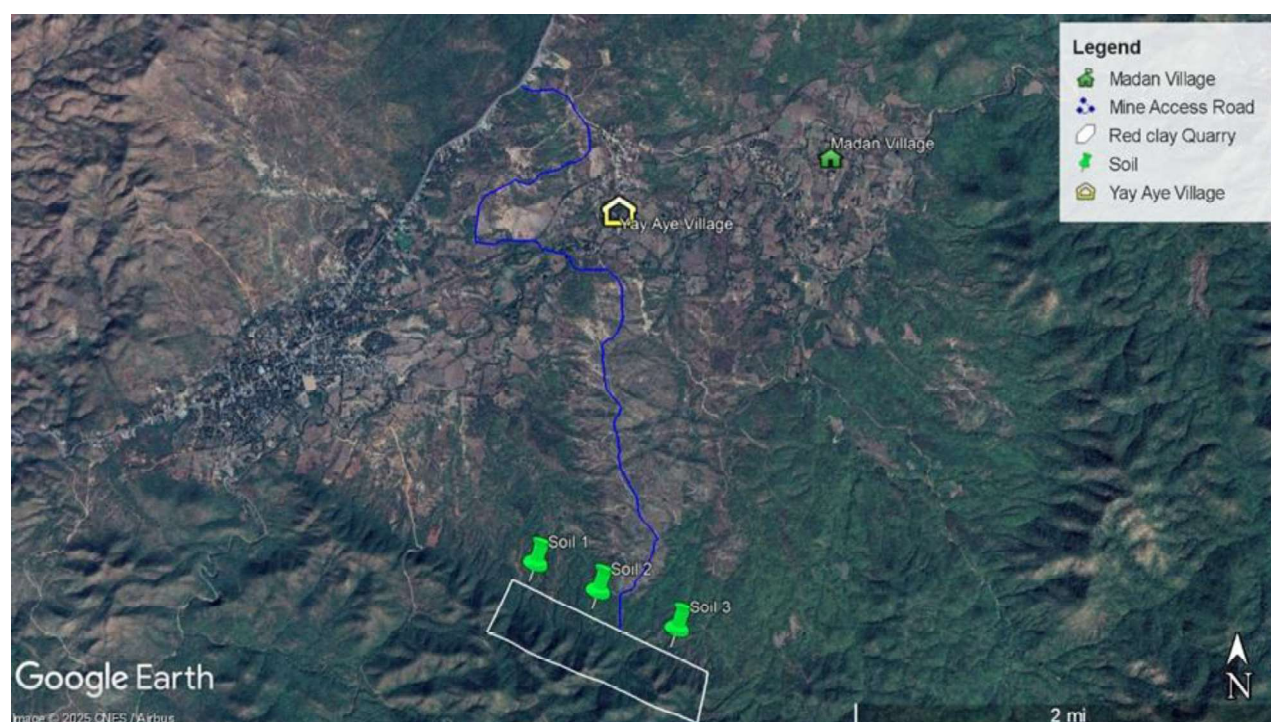
Figure – 6: Location of Soil Quality Monitoring

The Environmental Management Plan (EMP) for the Red Clay Quarry includes biannual soil quality monitoring at three designated sampling points within the quarry. However, **as extraction activities have not yet commenced, STM has not yet conducted soil quality monitoring.** To ensure a comprehensive assessment and compliance with the EMP, STM plans to initiate soil quality monitoring and send samples to an external laboratory for full parameter analysis as specified in the EMP when operation begin. Figure 6 illustrates the monitoring locations for soil quality.

No.	Monitoring Location		Latitude	Longitude
1	Monitoring Locations in EMP	Soil Quality Monitoring 1 in EMP (Top Soil)	20°44'36.23"N	96°20'00.87"E
2		Soil Quality Monitoring 2 in EMP (Open Pit)	20°44'29.60"N	96°20'17.30"E
3		Soil Quality Monitoring 3 in EMP (Tailing Soil)	20°44'20.22"N	96°20'37.90"E

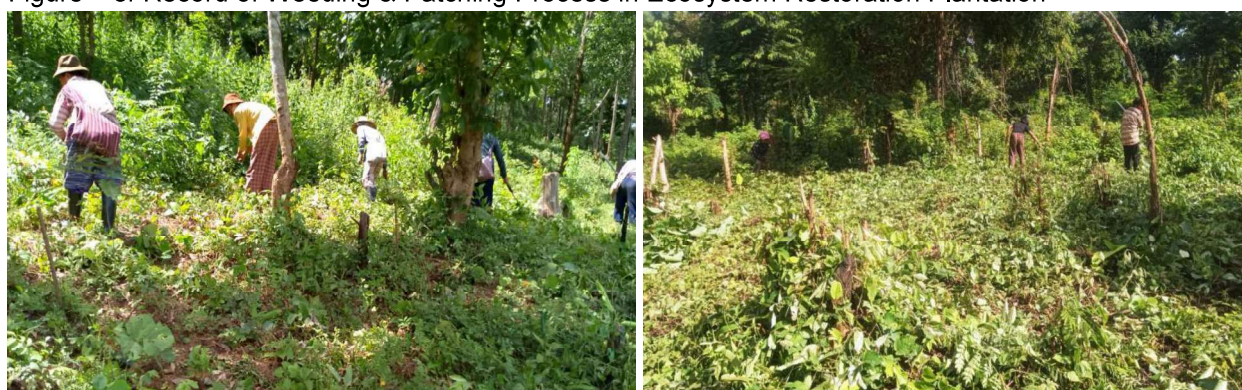
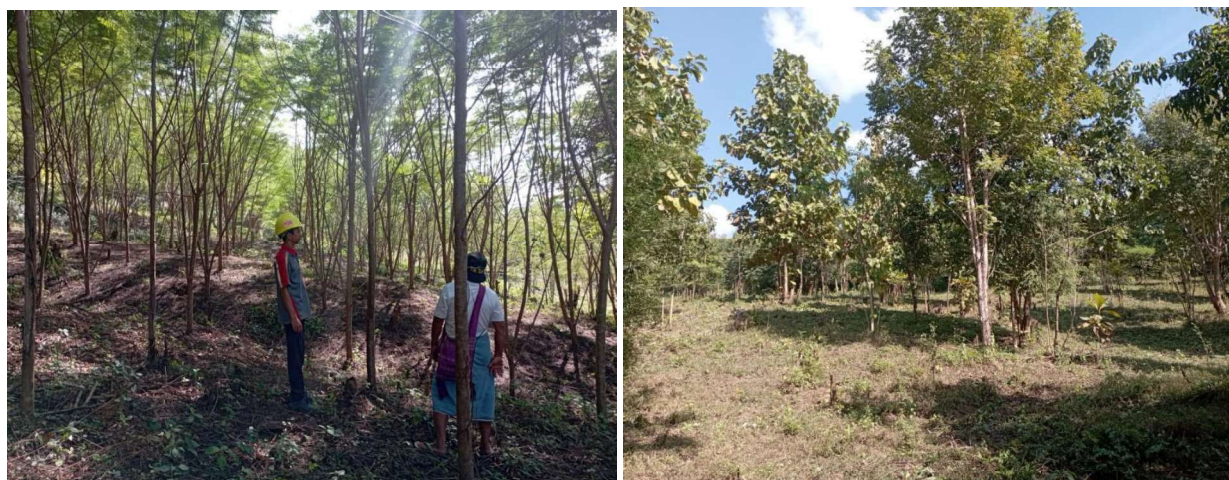
Figure – 8: Record of Weeding & Patching Process in Ecosystem Restoration Plantation

STM maintained the total 198 Arces Ecosystem Restoration Plantation including 28-acre ERP for red clay mine production. During the reporting period of August 2024 to January 2025, STM conducted the ERP maintenances as follow. (Table-7 & Table-8)

Additionally, ongoing nursery maintenance for the 28-acre Ecosystem Restoration Plantation in the Pyi Nyaung Reserved Forest has been conducted to support the continued health and growth of the planted areas. The nursery plantation list at January 2025 is as follow. (Table-9)

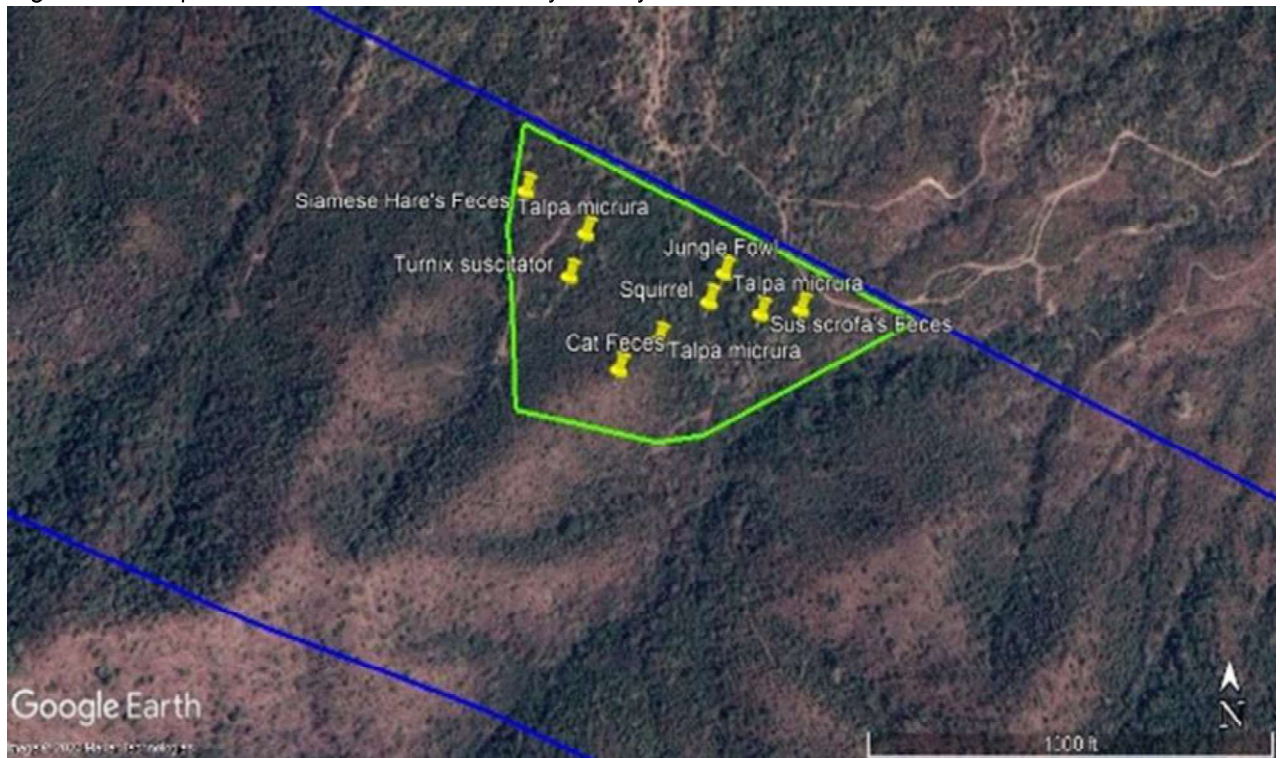
Figure – 9: Map of Land clearance at Red Clay Quarry

Moreover, STM conducted the land clearance before red clay production to conserve the biodiversity at this red clay mine area.

Name of Species			Location	Date	Time	Name of Target Species	Record (Information of Species)			Remark
Local Name	English Name	Scientific Name					Abundance	Dead/ Alive	Weather Condition	
တောဝက်	Eurasian Wild Pig	Sus scrofa	20°44'21.10"N 96°20'27.30"E	25-01-2024	10:38	-	1		Sunny	Feces
တောကြောင်	Leopard cat	Prionailurus bengalensis	20°44'20.48"N 96°20'24.58"E	25-01-2024	13:44	-	1		Sunny	Footprint & Feces
ရှင်	Phayre's Squarrel	Callosciurus erythraeus	20°44'21.37"N 96°20'25.93"E	25-01-2024	15:12	-	2	Alive	Sunny	Sighting
ငုံ	Barred Buttonquail	Turnix suscitator	20°44'21.95"N 96°20'22.24"E	25-01-2024	9:37	-	4	Alive	Sunny	Sighting
တောကြက်	Red Junglefowl	Gallus gallus	20°44'22.05"N 96°20'26.34"E	25-01-2024	10:02	-	1		Sunny	Feather
ယုန်	Siamese Hare	Lepus peguensis	20°44'23.98"N 96°20'21.05"E	25-01-2024	9:34		1		Sunny	Feces
ပွေး	Eastern Mole	Scalopus aquaticus	20°44'22.96"N 96°20'22.66"E	25-01-2024	9:25		1		Sunny	Nest
