# SHWE TAUNG CEMENT COMPANY LIMITED

## Biannual Environmental Monitoring Report

### (November 2024 to April 2025)

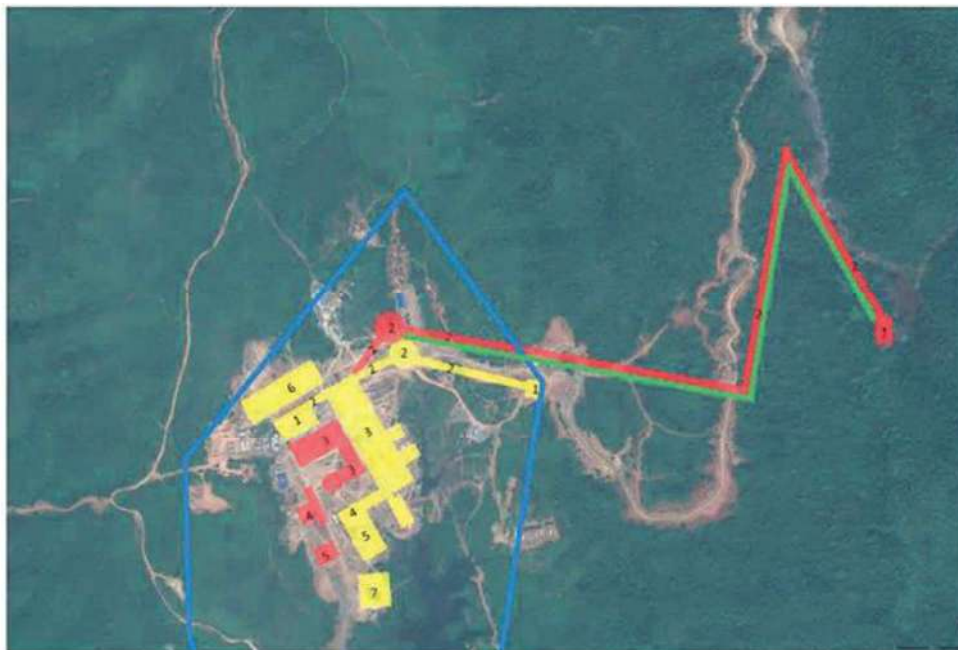
Figure – 2: Project Components of the Existing and Expanded STC Cement Plant

STC manufactures cement with clinker, gypsum and limestone (additive). Clinker is produced from limestone, mudstone, laterite and other materials. The clinker production and cement grinding capacity of the existing plant are 1,500 tpd and 2,800 tpd, respectively. The Project involves expanding the clinker production capacity to 5,500 tpd and 7,200 tpd of cement through the construction of a new rotary kiln and associated facilities. A dry process is used for the cement production and the second line will adopt a similar dry process as the first line, with additional facilities installed to achieve the increased capacity. These additional facilities will be installed within the existing 455-acre site.

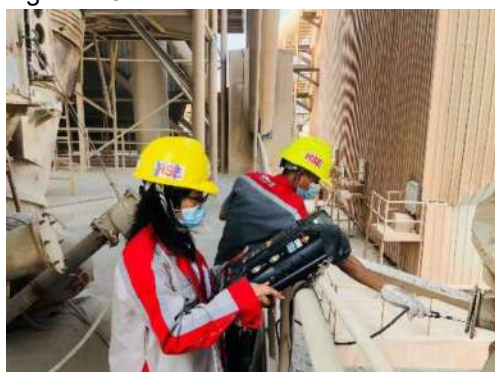
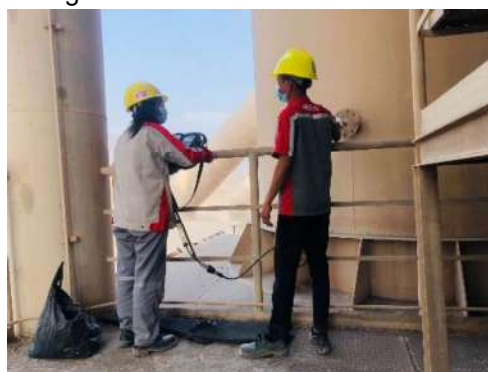
Figure – 3: Location of Kiln Stack Emission Monitoring

Figure 3 and 4 show the location of Kiln Stack Emission Monitoring and Ambient Air Monitoring monthly by Myanmar National Environmental Quality (Emission) Guidelines (2015) for Cement and Lime manufacturing (for NOx, SO2, PM2.5, PM10 etc.) are the parameters measured.

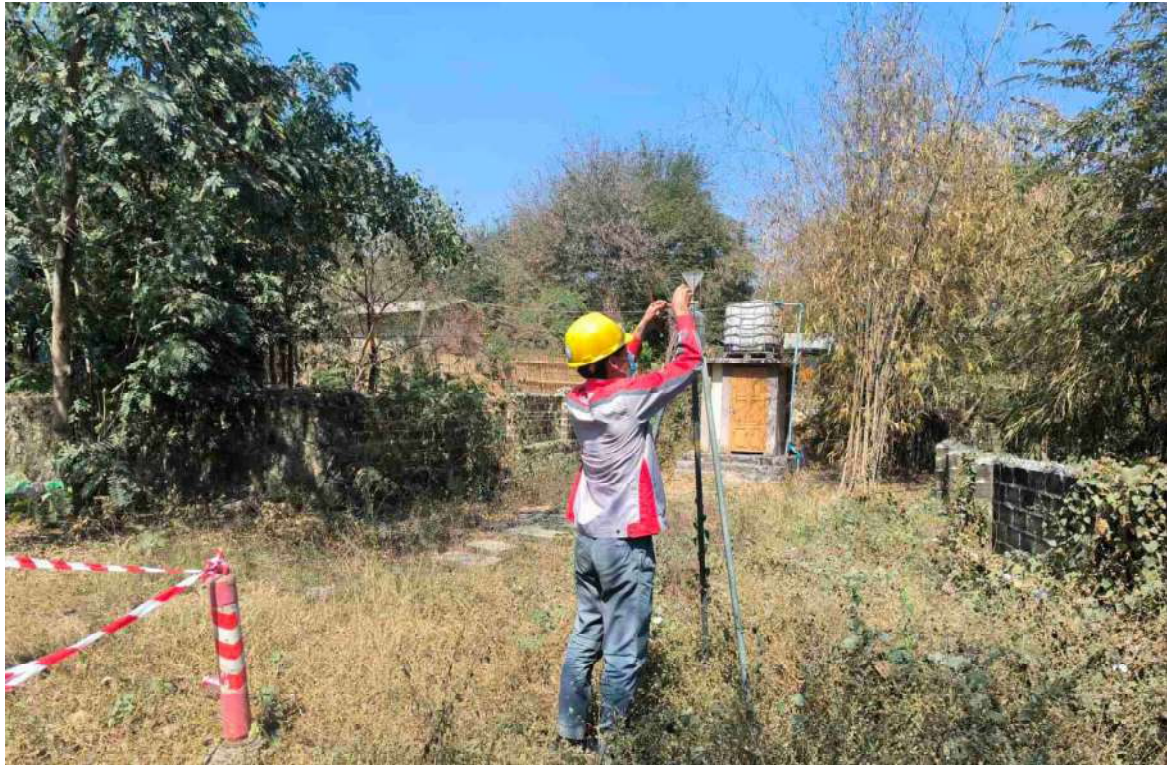
Figure – 6: Dust Deposition Monitoring

STC monitored dust deposition with 15 points at cement plant and limestone quarry, cement plant housing/ accommodation area, Ku Pyin and Pyi Nyaung village. The use of fabric/bag filter system and electrostatic precipitator to collect and control fine suspended particulate emissions are implemented in both lines of cement plant. Water suppression was also undertaken on the roads by using the water from sedimentation ponds to mitigate dust emission on surrounding area in plant site, quarries and plant accommodation area.

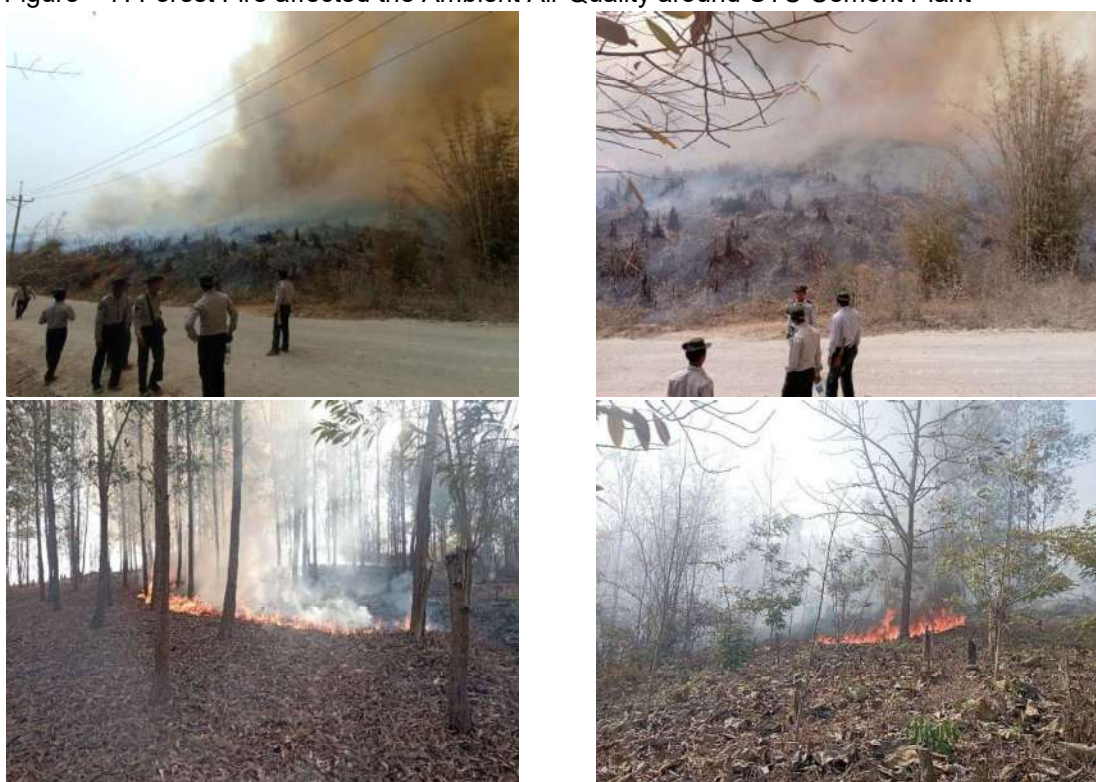
Figure – 7: Forest Fire affected the Ambient Air Quality around STC Cement Plant

By analyzing all the AQI results, it is noted that PM<sub>2.5</sub> values are majorly impacted by human activities (forest firing & open burning, etc.) from surrounding environment. STC will raise the public

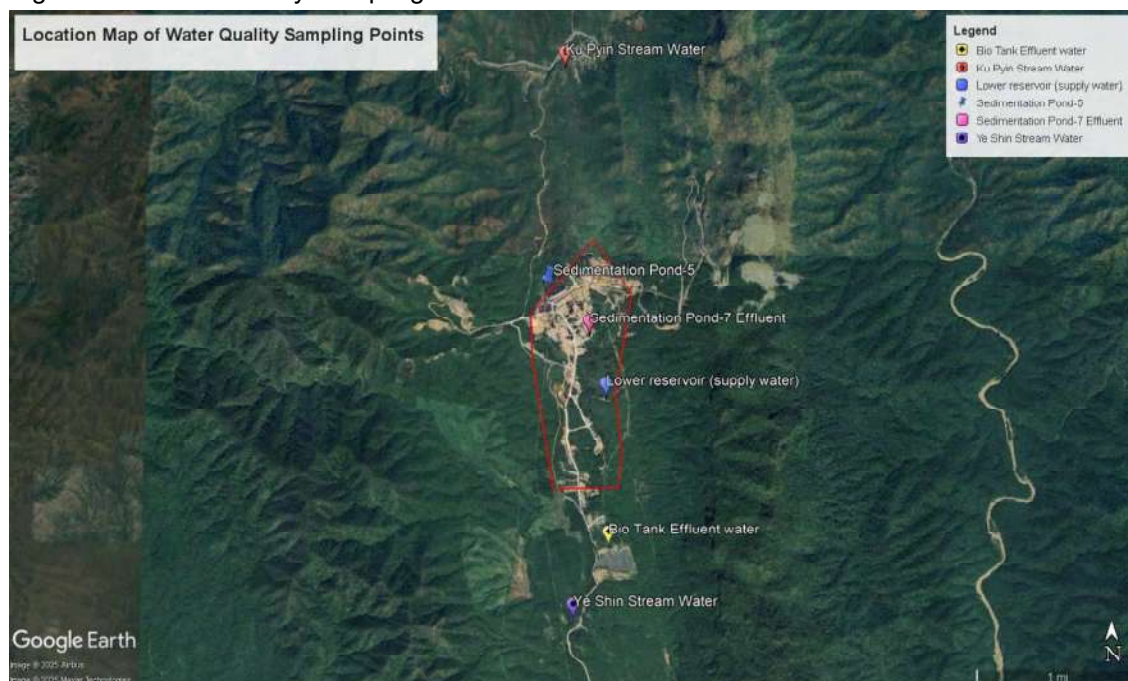
Figure – 9: Water Quality Sampling Points

Monitoring of water quality regularly is quite necessary for the assessment of water quality for beneficial purposes. Operation is dry process and do not generate wastewater. Sanitary wastewater from office and household are discharged to bio tank and treated wastewater are monitored in compliance with the NEQEG on BOD, COD, pH, SS, oil & grease, TN & TP and as per WHO Drinking water guidelines.

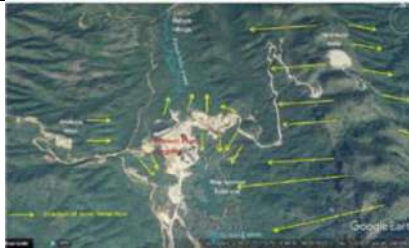
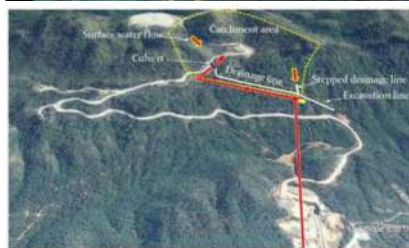
| Affected Aspect | Mitigation Measures | Action Taken | Photos |
|---|---|---|---|
| Surface Water Quality | <ul style="list-style-type: none"> <li>Implementing storm water management practices to manage the flow of storm-water, prevent uncontrolled migration and minimize erosion and sediment transport from project facilities and disturbed areas.</li> <li>Construction of a dedicated drainage network to intercept and diversion runoff;</li> </ul> | Constructed stormwater drains around the cement plant channel to sedimentation ponds | <p>Figure (2) Drainage for catchment area</p> |

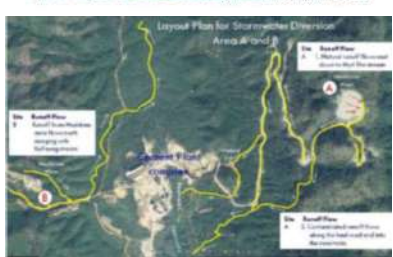
| Affected Aspect | Mitigation Measures | Action Taken | Photos |
|---|---|---|---|
| | <ul style="list-style-type: none"> <li>Divert runoff from the mudstone quarry to an appropriately sized and maintained sedimentation pond to allow adequate retention time for suspended solids to settle;</li> </ul> | Constructed sedimentation pond dual stage. | <p>Sedimentation pond from storm water runoff to allow adequate retention time for suspended solids to settle before entering downstream area.</p> <p>Location Map of Sedimentation Pond at STC Site</p> <p>Layout Plan for Stormwater Discharge Area at STC</p> |

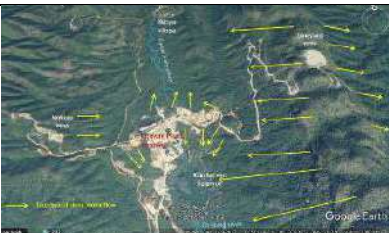
| | <ul style="list-style-type: none"> <li>STM will prepare and implement a Storm water Management Plan considering the mitigation committed above.</li> </ul> | Plan have been developed and construction on progress for Line 2 area. Line 1 area was constructed since 2014. | <p>Figure 2.2 Storm water flow, contour plan and limestone mining area</p> |

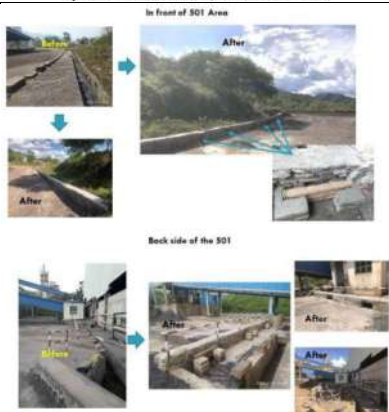
| | <ul style="list-style-type: none"> <li>All areas used to store and/or handle coal, laterite and limestone should be paved and surrounded by perimeter drains. For the coal storage area, it should be covered;</li> </ul> | Implemented and covered during monsoon season | |

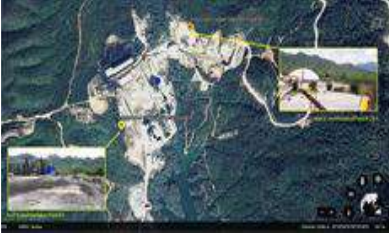
| | <ul style="list-style-type: none"> <li>Runoff from the laterite and limestone staging areas shall be diverted to retention ponds and may be used for greening, dust suppression or discharged to the onsite reservoir.</li> </ul> | Constructed sedimentation pond dual stage and reuse for gardening and dust control. | |

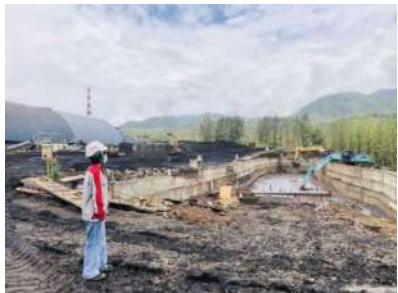
| | <ul style="list-style-type: none"> <li>For the coal storage area, STM has agreed to cover this area. Water from the roof will be diverted via storm water drains to retention ponds and may be used for greening, dust suppression or discharged to the onsite reservoir. Runoff collected by the interceptor drains (small volume) within the covered coal storage area will be diverted for treatment at the wastewater treatment plant.</li> </ul> | <p>Upgraded sedimentation pond near coal storage area.</p> | |

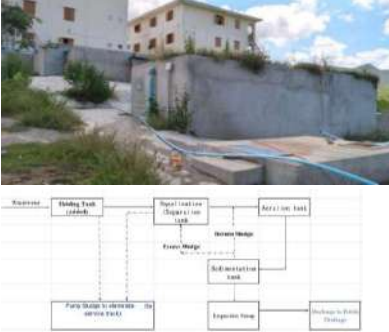
| | <ul style="list-style-type: none"> <li>Sanitary wastewater (includes toilet, sink, shower) should be discharged to the wastewater treatment plant and not be directly discharged to any water bodies. Kitchen flows should be discharged for treatment at dedicated grease trap / water purification unit and not be directly discharged to any water bodies.</li> </ul> | Constructed Bio Tank for treatment of sanitary wastewater. | |

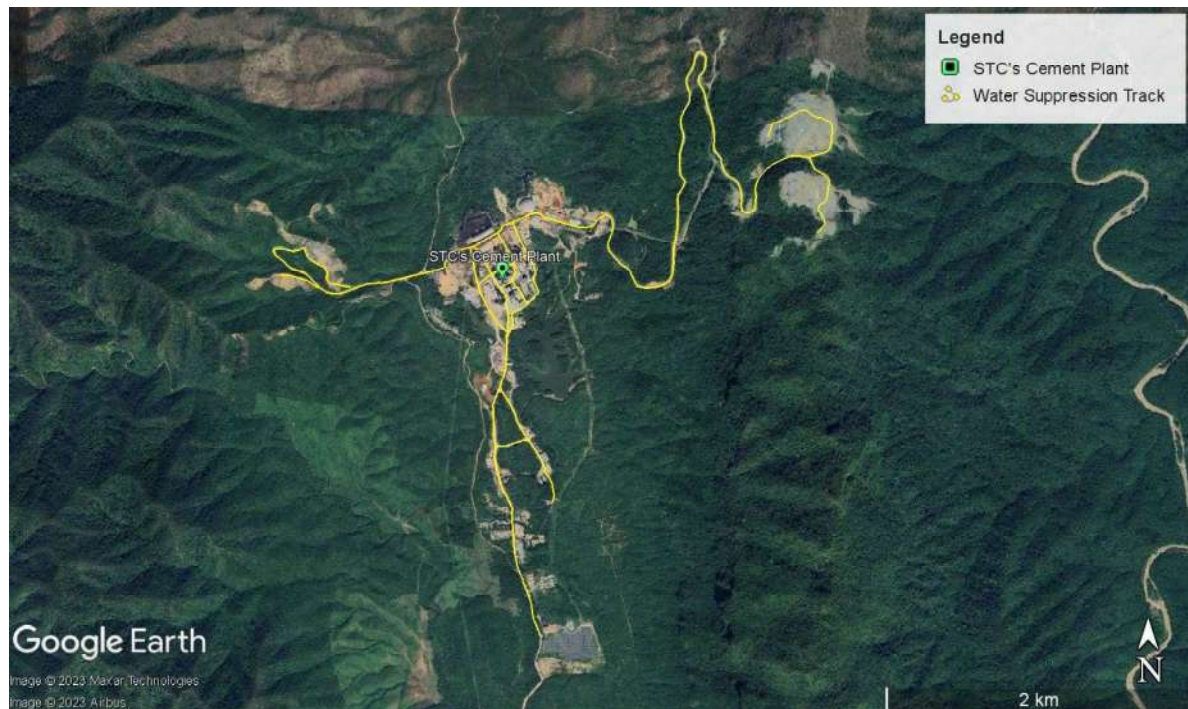
Figure: Water Suppression Map to mitigate dust emission in plant site

The use of fabric filter system and electrostatic precipitator to collect and control fine suspended particulate emissions are implemented. Water suppression are also undertaken on the roads to mitigate dust emission on surrounding area in plant site and accommodation area. (See in Appendix-A2)

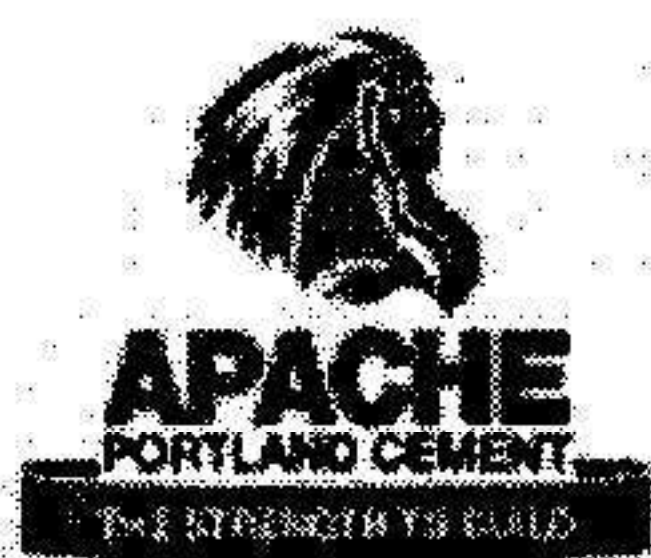
## **APPENDIX - (B-5)** **(Sedimentation Pond 5 Water Results)**

Nature of water                      Surface Water  
Location                                Beside 103 & 501 Area  
Date of sample collection        27.11.2024  
Date of sample examination      28.11.2024  
Date of completing                29.11.2024

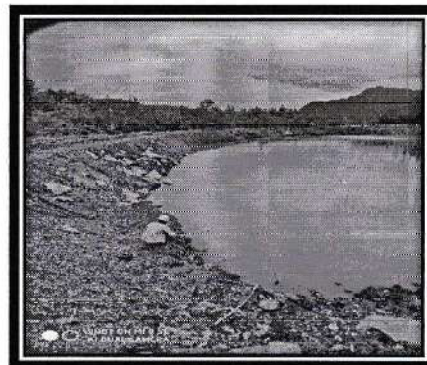
**Waste Water Test Report**

Nature of water                      Surface Water  
Location                                Beside 103 & 501 Area  
Date of sample collection        17.12.2024  
Date of sample examination      18.12.2024  
Date of completing                20.12.2024

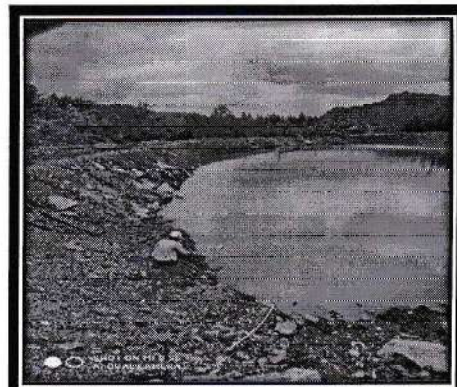
Waste Water Test Report

Nature of water                      Surface Water  
Location                                Beside 103 & 501 Area  
Date of sample collection        16.04.2025  
Date of sample examination      16.04.2025  
Date of completing                18.04.2025

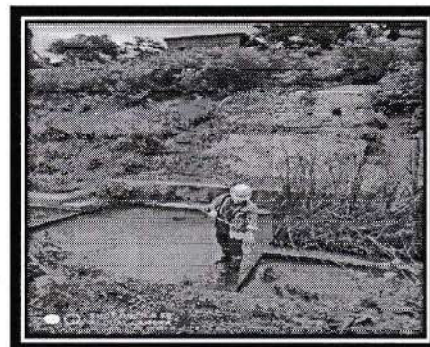
**Waste Water Test Report**

Nature of water                      Surface Water  
Location                                Between 401 & 405  
Date of sample collection        14.01.2025  
Date of sample examination      15.01.2025  
Date of completing                19.01.2025

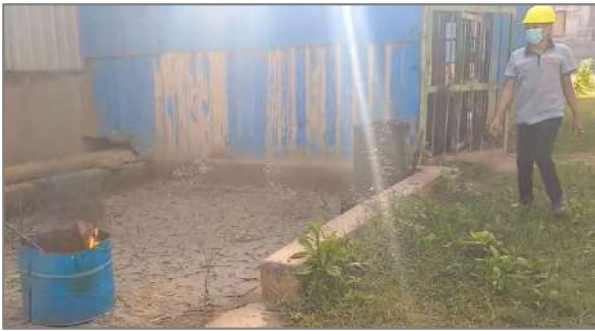
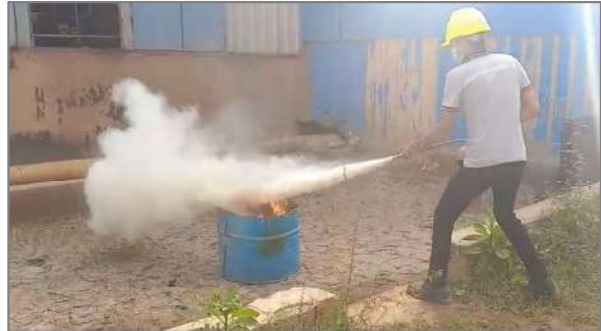
c) Site in charge manage to extinguished lubricant fire using by fire extinguisher
