SHWE TAUNG MINING COMPANY LIMITED

Bi-Annual Environmental Monitoring Report

SHWE TAUNG MINING COMPANY LIMITED
Mudstone Quarry
Biannual Environmental Monitoring Report
(May 2025 to October 2025)

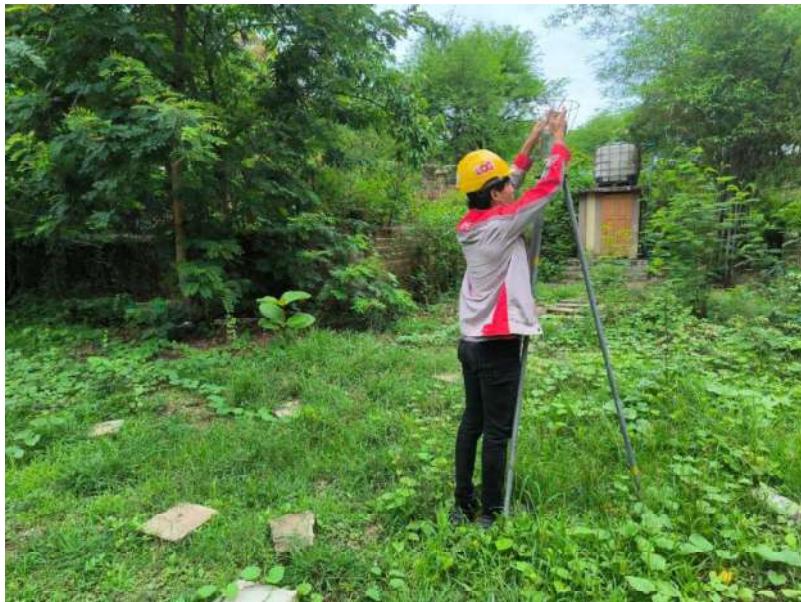
Figure-3: Dust Deposition Monitoring

Samplers: Nay Hlaing Oo	Dust Deposition Monitoring						
	Test Result						
Parameter	Australia & New Zealand Guideline (g/m ² /Day)	May 2025	Jun 2025	Jul 2025	Aug 2025	Sep 2025	Oct 2025
STM Accommodation (Ingyin Hostel)	1.191 (g/m ² /Day)	1.71	0.54	0.46	0.09	0.60	0.57
STM Accommodation (55acres)		1.1	0.28	0.26	0.05	0.34	0.50
Ku Pyin (Behind Library)		0.53	0.44	0.68	0.10	0.53	0.51
Ku Pyin (Primary School)		0.38	0.41	0.51	0.06	0.36	0.36
Pyi Nyaung (Near Main Road)		0.94	0.38	0.44	0.16	0.64	0.43
Pyi Nyaung (Information Center)		0.92	0.18	0.21	0.07	0.24	0.46

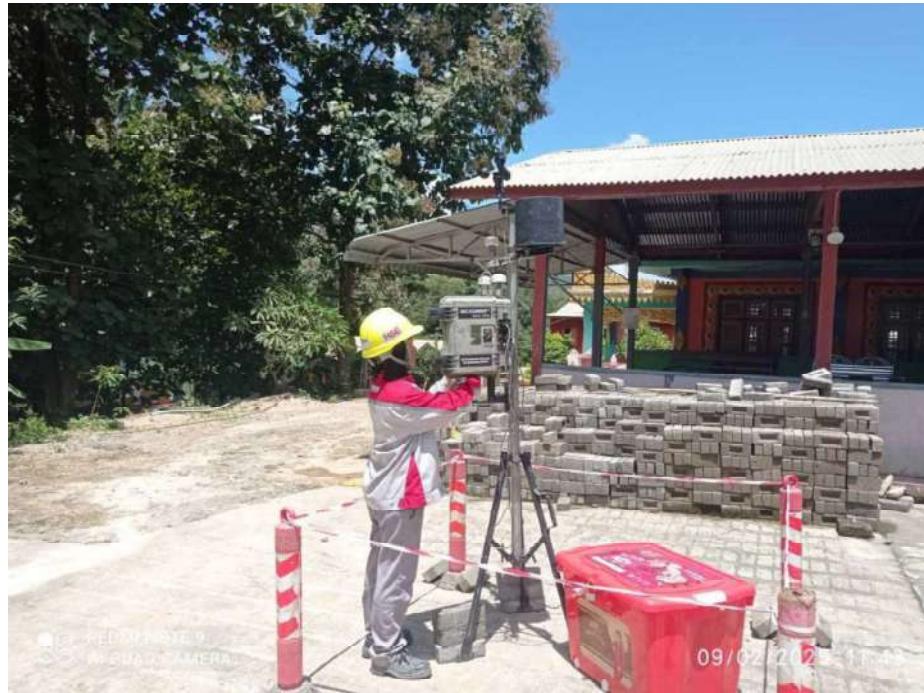
Figure – 4: Ambient Air Quality Monitoring

Ambient Air Quality monitoring is measured with portable HAZ-SCANNER™ EPAS device. Ambient air quality monitoring location had been selected by identifying potentially affected with consideration given to the prevailing wind conditions through Operation and Construction activities.

The portable HAZ-SCANNER™ EPAS wireless environmental perimeter air station is easily deployed as an ambient air quality monitor to measure and document critical U.S. EPA criteria pollutants including nitrogen dioxide, sulfur dioxide, ozone, carbon dioxide, particulates, VOCs, and more. The EPAS provides direct readings in real time with data logging capabilities.

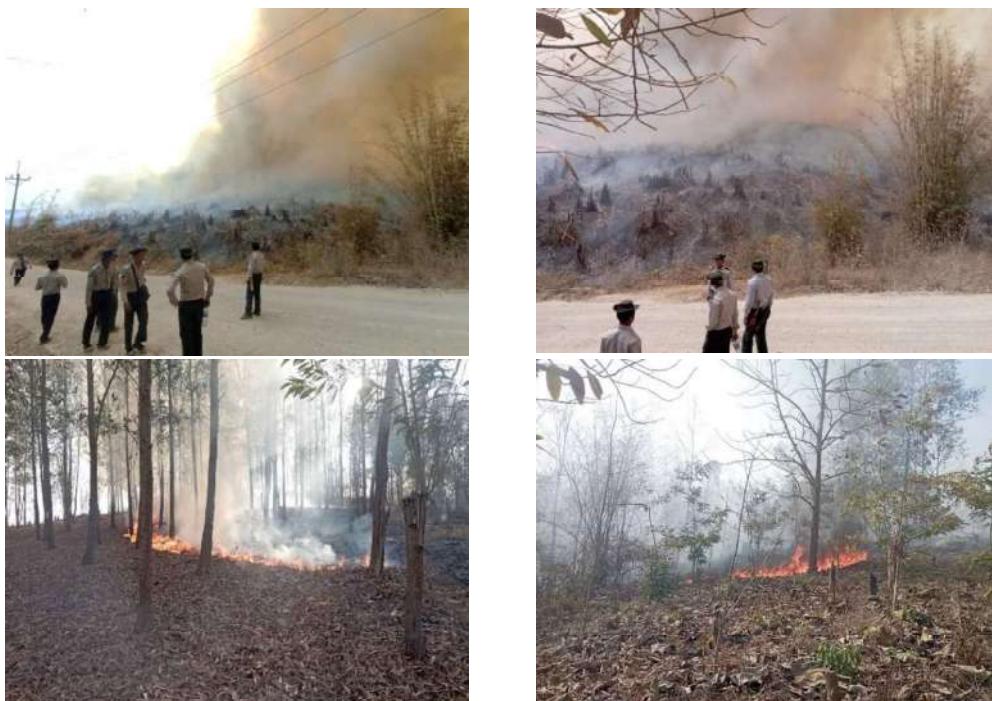
Figure-7: Human activities affected the Ambient Air Quality around STM Mudstone Quarry

Ambient Air monitoring was monthly tested at location of Sensitive Air Respecters such as Cement Plant Accommodation, and nearby villages which are Pyi Nyaung and Ku Pyin as in Cement Plant EIA report. All results are within Myanmar National Environmental Quality (Emission) Guidelines (2015), except higher results of PM2.5 and SO₂ in some months. These increases are likely attributable to frequent forest fires initiated by some local villagers for land clearing, as well as slash-and-burn practices conducted by Forest Department for teak plantation management near the STC area.

By analyzing all the AQI results, it is noted that PM 2.5 values are majorly impacted by human activities (forest firing & open burning, etc.) from surrounding environment. STM will raise the public awareness among Mudstone Quarry community and also disclosed these air quality monitoring results and AQI results at Pyi Nyaung Information Center and Ku Pyin library according to STM Stakeholder Engagement Plan.

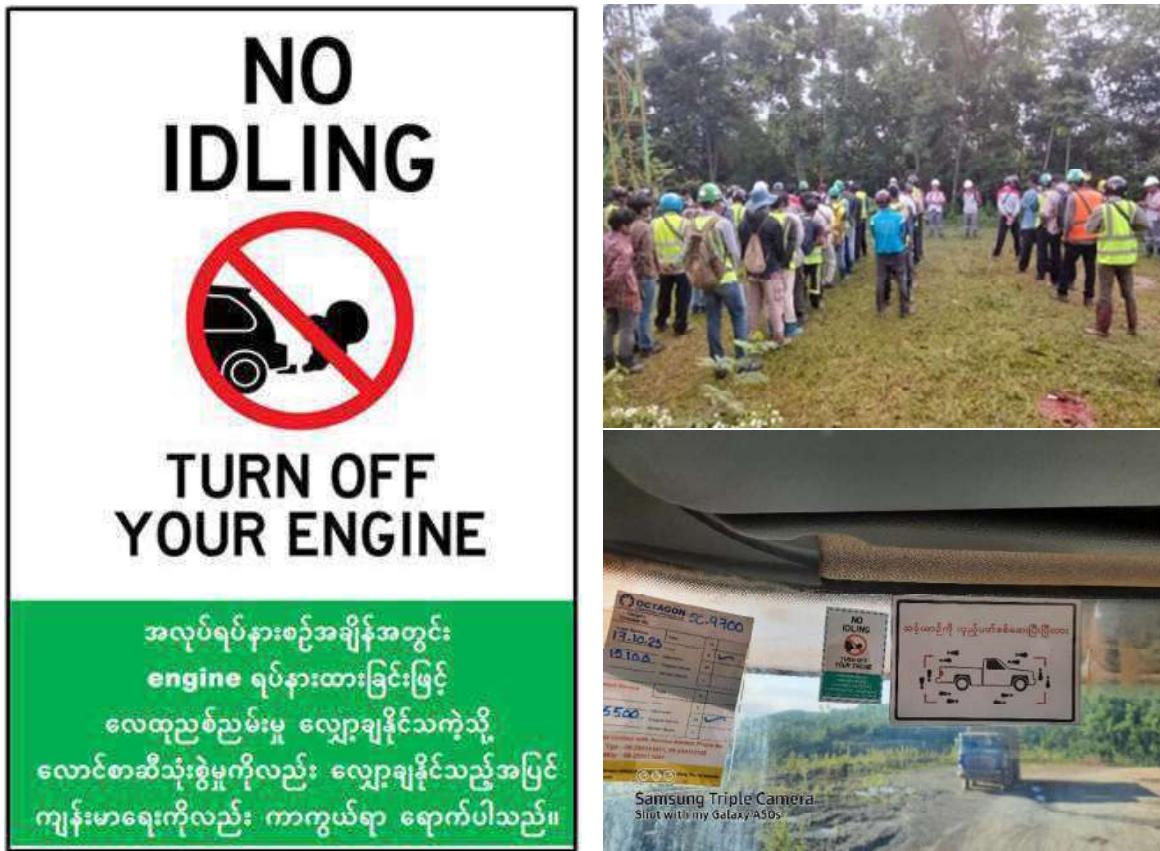
Figure – 8: Photo Records of "No Idling: Turn Off Your Engine Sticker Campaign"

Therefore, STM was looking other factors that can be impacting on SO₂ results and found out that it was related to emission of mobile vehicles that were higher SO₂ than Kiln emission by using Testo PG-350 Portable Combustion and Emission Analyzer at STC Apache cement plant. There were a lot of heavy machineries and trailer trucks movement during day time and only trailer trucks movement during night time. So STM has raised awareness among the vehicle drivers to stop when they are parking or waiting, with sticker campaign "Turn Off Your Engine While Waiting or Parked" at Apache Cement plant in October 2025. The campaign involved the distribution and installation of "No Idling: Turn Off Your Engine" stickers at the main entrance, vehicle parking areas, and security gates. Furthermore, toolbox meetings and awareness sessions were conducted to educate drivers, contractors, and staff about the environmental and health impacts of vehicle idling and the benefits of adopting this practice.

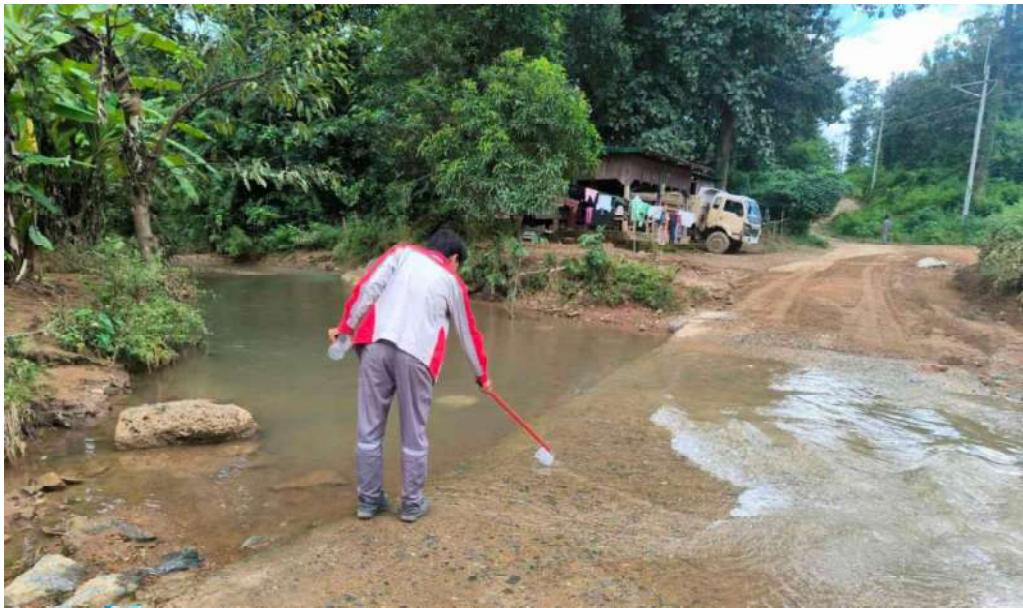
Figure-12: Water Quality Sampling Record

Monitoring of water quality regularly is quite necessary for the assessment of water quality for beneficial purposes. Operation is dry process and do not generate wastewater. Sanitary wastewater from office and household are discharged to bio tank and treated wastewater are monitored in compliance with the NEQEG on BOD, COD, pH, SS, oil & grease, TN & TP and as per WHO Drinking water guidelines.

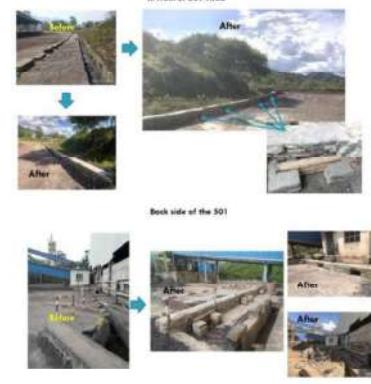
Figure 3.2) Storm water flow, canal plan and limestone mine area

<ul style="list-style-type: none"> All areas used to store and/or handle coal, laterite and limestone should be paved and surrounded by perimeter drains. For the coal storage area, it should be covered; 	Implemented and covered during monsoon season

In Front of 801 Area Before After After Back side of the 301 Before After After

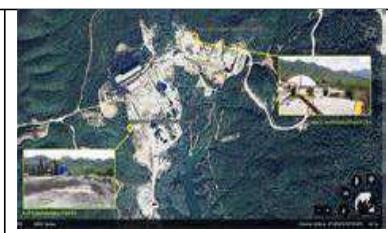
<ul style="list-style-type: none"> Runoff from the laterite and limestone staging areas shall be diverted to retention ponds and may be used for greening, dust suppression or discharged to the onsite reservoir. 	<p>Constructed sedimentation pond dual stage and reuse for gardening and dust control.</p>

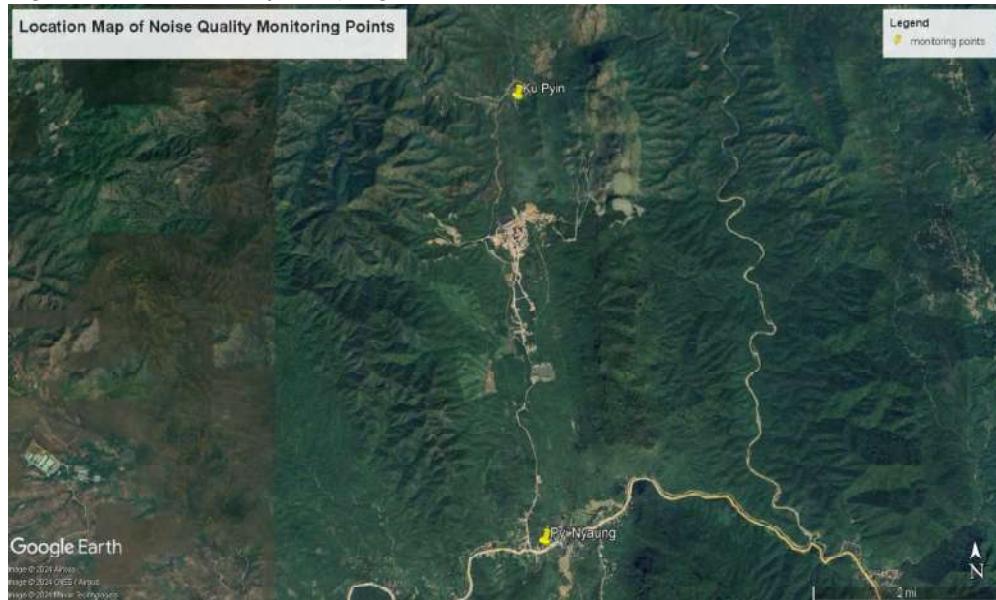
Figure-13: Noise Quality Sampling Points

No	Noise Monitoring Location	Latitude	Longitude
1	Ku Pyin Village	20°53'20.47"N	96°23'27.58"E
2	Pyi Nyaung Village	20°49'4.58"N	96°23'40.42"E

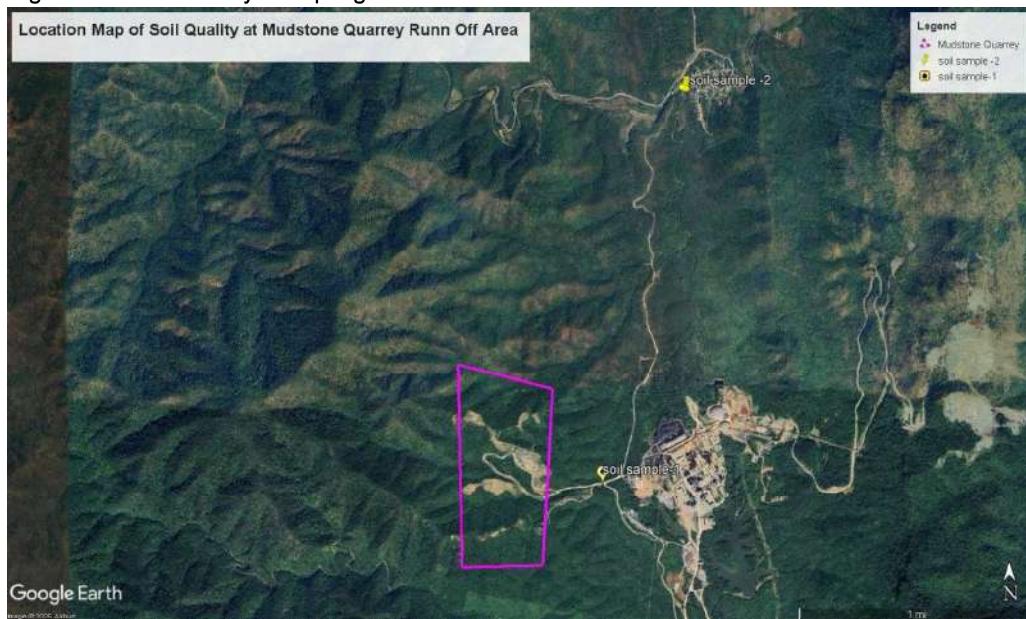
Figure-14: Soil Quality Sampling Points

In accordance with the commitments outlined in the Approval Letter, STM is required to conduct biannual monitoring of soil quality parameters, including pH, Moisture Content (dried at 103°C), Electrical Conductivity, Cadmium, Copper, Lead, Zinc, and Iron at the mudstone runoff area. Accordingly, STM collected soil samples from the mudstone runoff area and Ku Pyin Village, which were subsequently submitted to the Department of Agriculture (Land Use) Laboratory for analysis of all required parameters. The sampling locations are presented in Figure 14, and the laboratory-analyzed soil quality monitoring results are provided in Table 22.

The soil quality monitoring results indicate that the measured parameters at both Ku Pyin Village and the mudstone runoff area are within acceptable environmental standards and show no evidence of contamination from project activities. The pH levels at both locations fall within the slightly alkaline to slightly acidic range, which is suitable for natural soil conditions. Moisture content was found to be lower than the baseline value, suggesting dry surface conditions during the sampling period. Electrical conductivity values were also low, indicating minimal soluble salt presence. Concentrations of heavy metals—copper (Cu), lead (Pb), and zinc (Zn)—were substantially lower in the test results than in baseline levels. According to international standards, such as those provided by the Food and Agriculture Organization (FAO) Soil Bulletin 65 & Dutch Standard, these concentrations are well within the Maximum Permissible Limits (MPL) for agricultural soils, indicating no immediate risk of heavy metal contamination. These findings suggest that the current soil conditions are environmentally stable and suitable for agricultural or reclamation purposes.

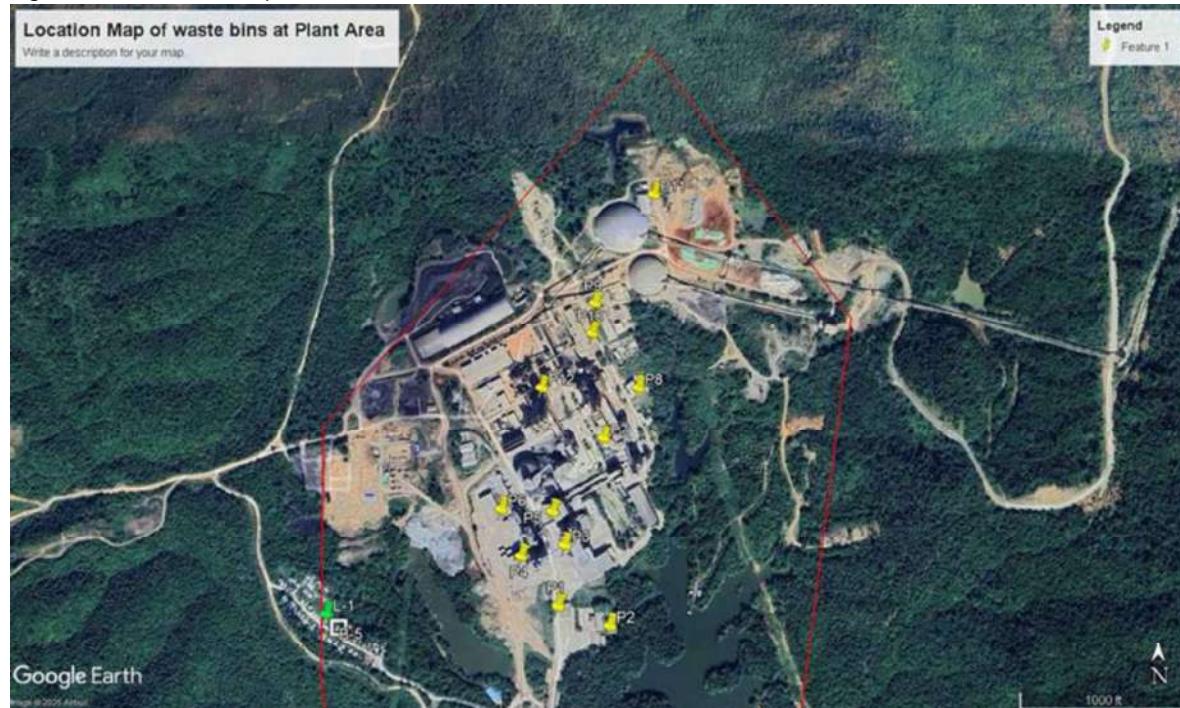
Figure-15: Location Map of Collection Points of All Generated Wastes from Plant Site

In Shwe Taung Cement Factory, collect non-hazardous waste generated from plant site and accommodation area every day and dispose them to Temporary Non-hazardous Storage Area. For kitchen wastes, compost or use as animal feed in nearby villages. On the other hand, dispose laboratory and clinical wastes to Meiktila Incinerator, Meiktila District, Mandalay Region, approved by Meiktila City Development Committee and have plan to dispose hazardous wastes to Golden Dowa Eco-system Myanmar Co., Ltd., Accredited Waste Management Company. Figure 15, 16 and 1 show location map of waste disposal area and waste collection points.

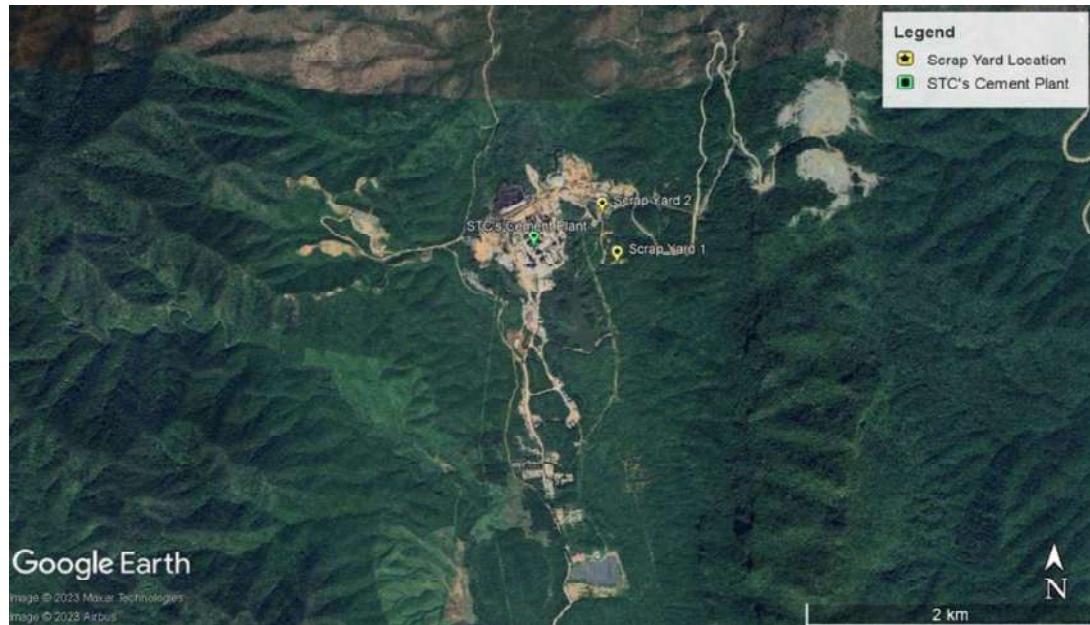
Figure-18: Location Map of Site Waste Dumping Area (Scrap Yard)

<ul style="list-style-type: none"> Segregate wastes and recycle wherever possible; 	Segregated scrap materials for resale and reuse (See Figure-13 for Scrap Yard Area)

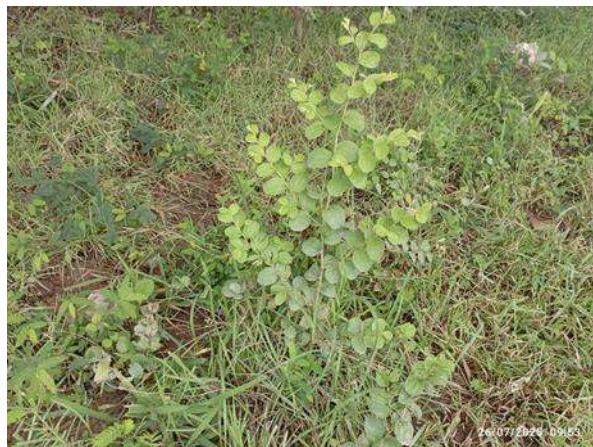
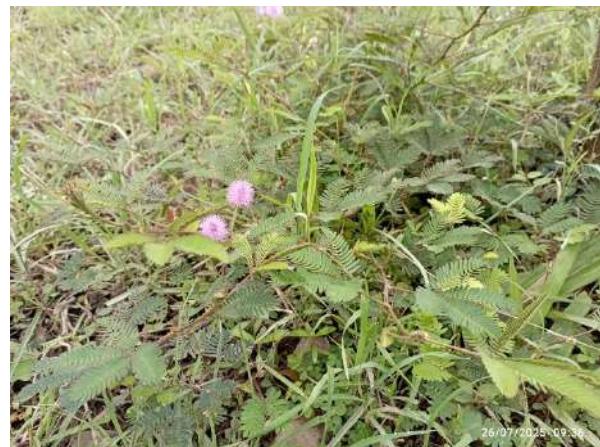
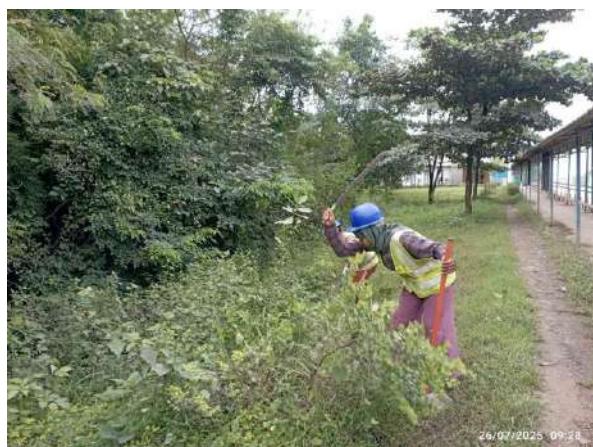
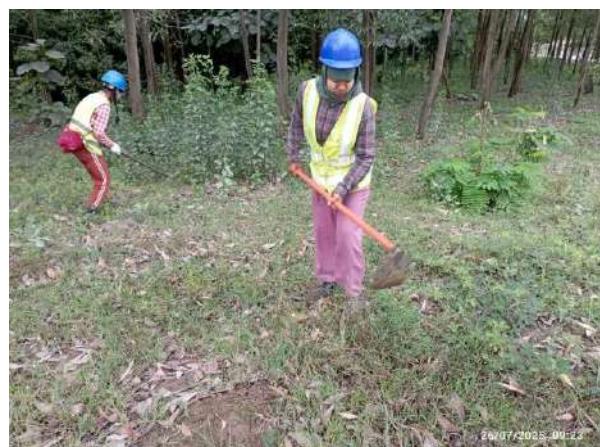
Figure – 20: Photo Records from Invasive Species Survey in July 2025

An invasive flora species survey was conducted within the plant boundary on 26 July 2025. The survey was carried out by walking along established transect lines and recording the occurrence and abundance of invasive plant species. As part of ongoing management measures, clearing and eradication activities were implemented throughout the plant area to prevent the spread of invasive species. During the survey, photographic records were taken for documentation and verification purposes. A total of eight invasive flora species were identified within the surveyed area, namely *Khwe-thay-pan*, *Hmwe-sok*, *Bi-zet*, *Bein-new*, *Baw-za-gaing*, *Hti-ka-yone*, *Kyaung-sha*, and *Zi*.

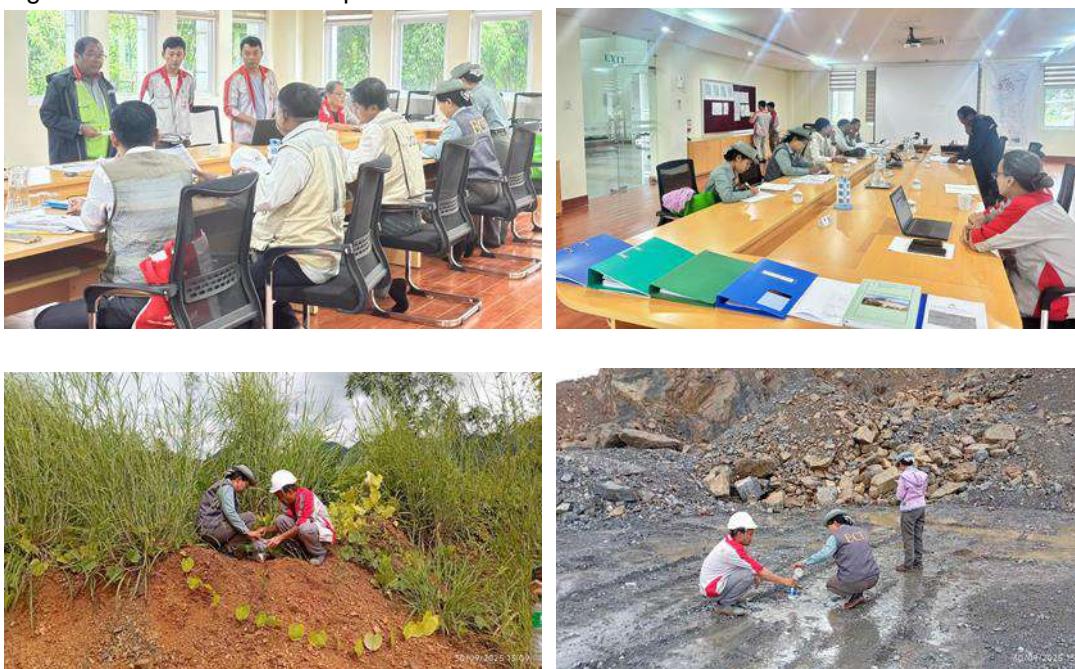
Figure – 25: Government Inspection Photo records

On 30 September 2025, representatives from Mining 1 Enterprise and the Meikhtila District Environmental Conservation Department (ECD) conducted a site inspection at the quarry as part of the license extension process. The inspection team reviewed the updated conditions of the mudstone mining operations, as well as the water and soil quality sampling activities conducted at the site. The corresponding water and soil quality analysis results are provided in Appendix G.

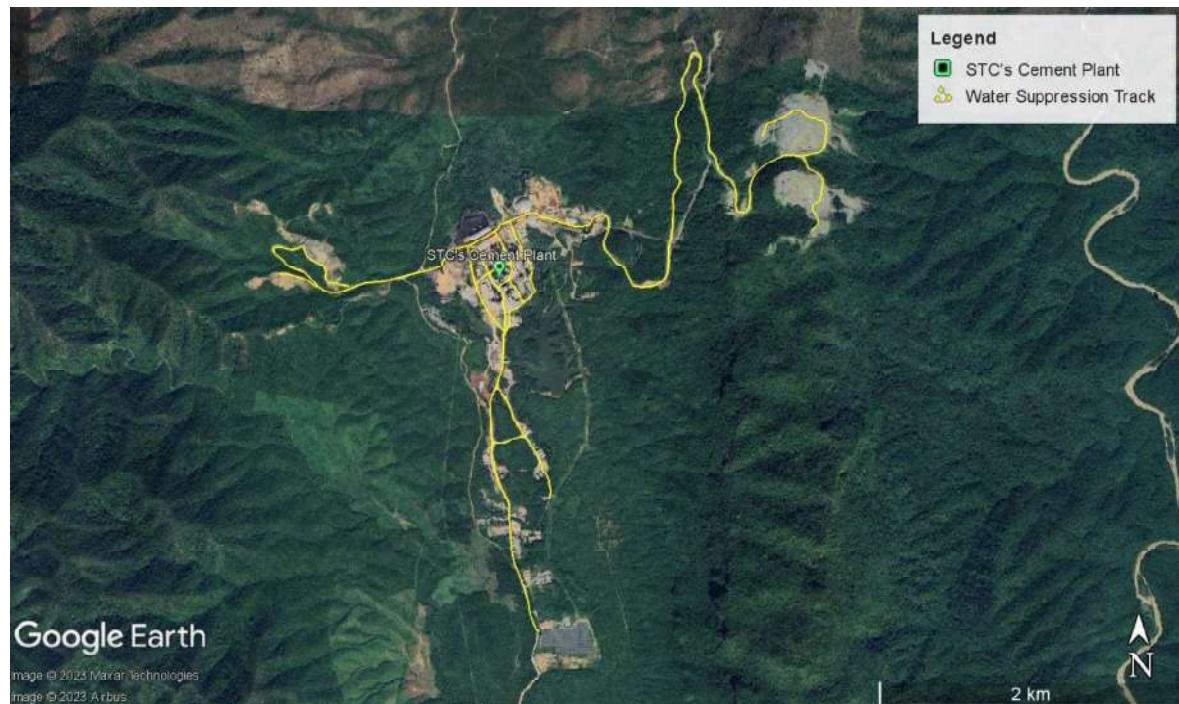
Figure: Water Suppression Map to mitigate dust emission in plant site

Water Suppression Record 2025												
Month	Vehicle No.											
	5B-4174 (Capacity: 2200 gal)		6C-1052 (Capacity: 4000 gal)		2R-5191 (Capacity: 800 gal)		1P-4508 (Capacity: 4500 gal)		2R-5193 (Capacity: 800 gal)		7G-9512 (Capacity: 2800 gal)	
	Total Load	Water Consumption	Total Load	Water Consumption	Total Load	Water Consumption	Total Load	Water Consumption	Total Load	Water Consumption	Total Load	Water Consumption
May 2025	-	-	99	396,000	-	-	65	292,500	59	47,200	107	299,600
June 2025	-	-	72	288,000	-	-	85	382,500	65	52,000	151	422,800
July 2025	-	-	-	-	-	-	53	238,500	85	68,000	210	588,000
Aug 2025	-	-	-	-	-	-	83	373,500	131	104,800	188	526,400
Sep 2025	-	-	29	116,000	-	-	87	391,500	45	36,000	37	103,600
Oct 2025	-	-	103	412,000	-	-	79	355,500	3	2,400	-	-

Affected Aspect	Mitigation Measures	Action Taken	Photos
Air Quality	• Water suppression should be used on unpaved roads and work areas in dry and windy conditions;	Water suppression are undertaken on the roads to mitigate dust emission on surrounding area in plant site and accommodation area. (See in Appendix A).

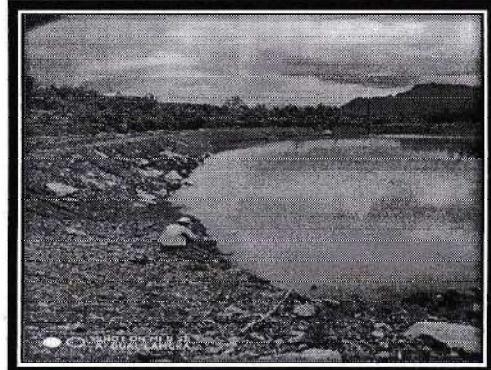
Nature of water Surface Water
Location Beside 103 & 501 Area
Date of sample collection 20.08.2025
Date of sample examination 21.08.2025
Date of completing 22.08.2025

Description of Analysis	Analysis Results	IFC Waste Water Guideline	Remark
pH	7.8	6-9	
Chemical Oxygen Demand(COD)	-	0-125mg/L	no stock chemical
Biological Oxygen Demand(BOD)	-	0-30mg/L	no stock chemical
Total Suspended Solid(TSS)	46	Max 50mg/L	
Total Nitrogen	-	10mg/L	no stock chemical
Total Nitrate	-	44.29mg/L	no stock chemical
Total Phosphorous	-	2mg/L	no stock chemical

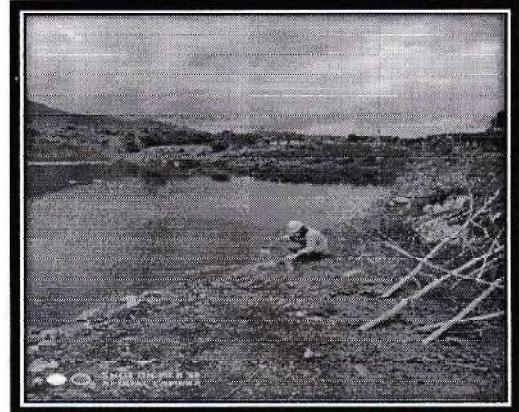
Nature of water Surface Water
Location Infront of Main Office
Date of sample collection 20.08.2025
Date of sample examination 21.08.2025
Date of completing 22.08.2025

Description of Analysis	Analysis Results	IFC Waste Water Guideline	Remark
pH	7.9	6-9	
Chemical Oxygen Demand(COD)	-	0-125mg/L	no stock chemical
Biologycal Oxygen Demand(BOD)	-	0-30mg/L	no stock chemical
Total Suspended Solid(TSS)	74	Max 50mg/L	
Total Nitrogen	-	10mg/L	no stock chemical
Total Nitrate	-	44.29mg/L	no stock chemical
Total Phosphorous	-	2mg/L	no stock chemical

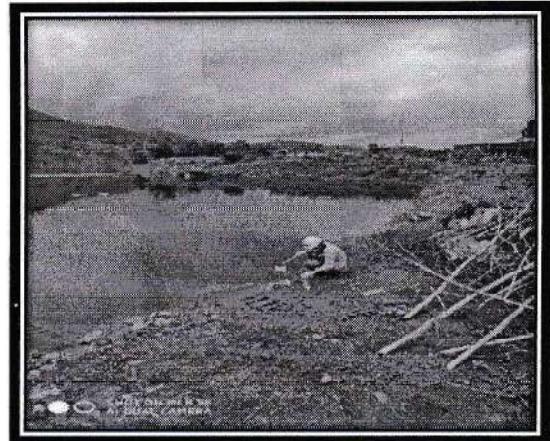
Nature of water Surface Water
Location Infront of Main Office
Date of sample collection 17.10.2025
Date of sample examination 18.10.2025
Date of completing 19.10.2025

Description of Analysis	Analysis Results	IFC Waste Water Guideline	Remark
pH	8.6	6-9	
Chemical Oxygen Demand(COD)	-	0-125mg/L	no stock chemical
Biological Oxygen Demand(BOD)	-	0-30mg/L	no stock chemical
Total Suspended Solid(TSS)	397	Max 50mg/L	
Total Nitrogen	-	10mg/L	no stock chemical
Total Nitrate	-	44.29mg/L	no stock chemical
Total Phosphorous	-	2mg/L	no stock chemical

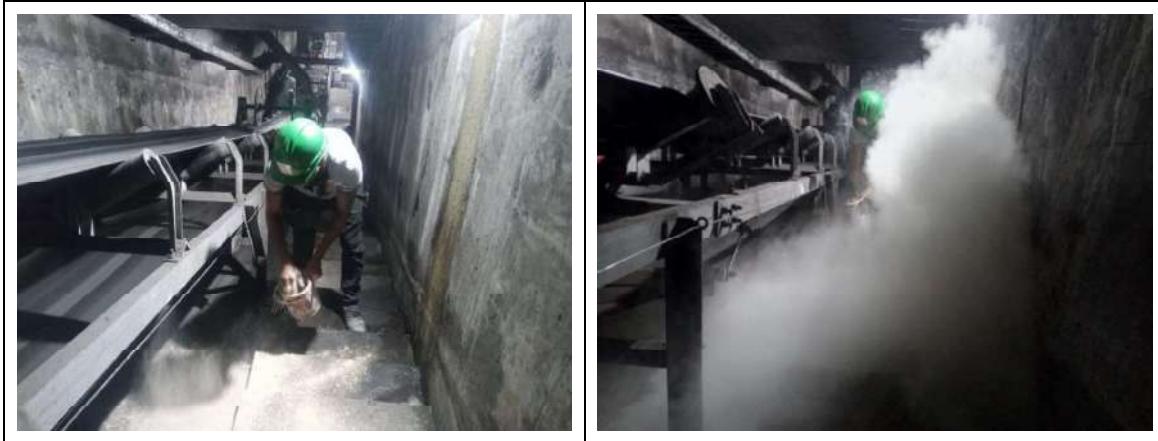
c. CPP site operator try to extinguish coal smoldering using by raw meal

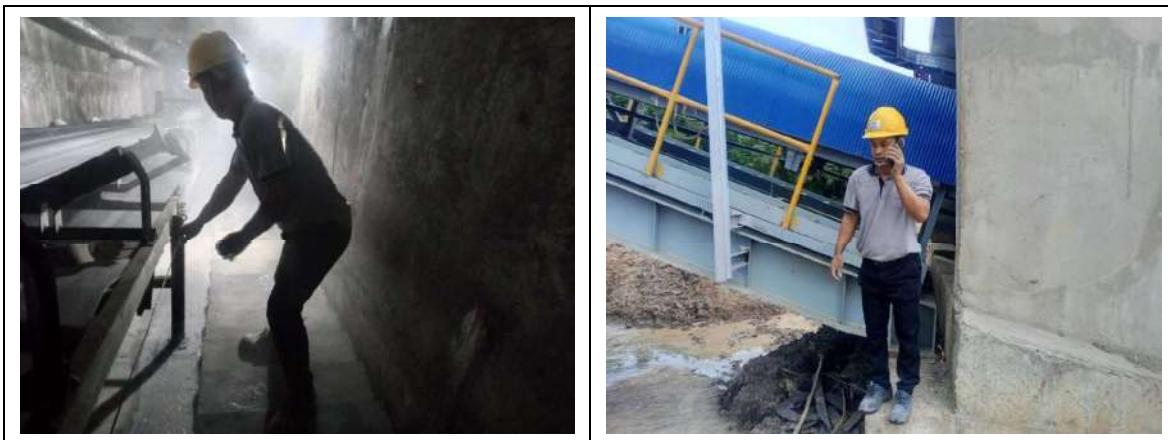
d. Site supervisor stop belt conveyor using pull cord and inform to emergency hot line

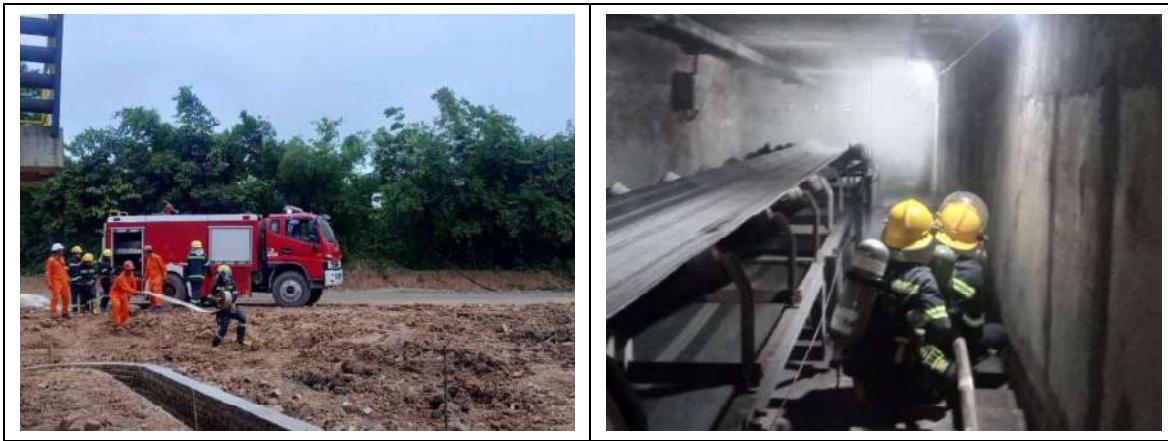
h. firefighting team extinguished fire
