SHWE TAUNG MINING COMPANY LIMITED**Red Clay Quarry****Biannual Environmental Monitoring Report****(10 February 2025 to 9 August 2025)**

August 2025	Bi-annual reporting to ECD		Hein Latt Environmental Manager	Head of HSE	Kyaw Naing Soe Deputy MD of STM
Rev	Date	Description	Code / Ref.	Prepared by	Checked by	Approved by

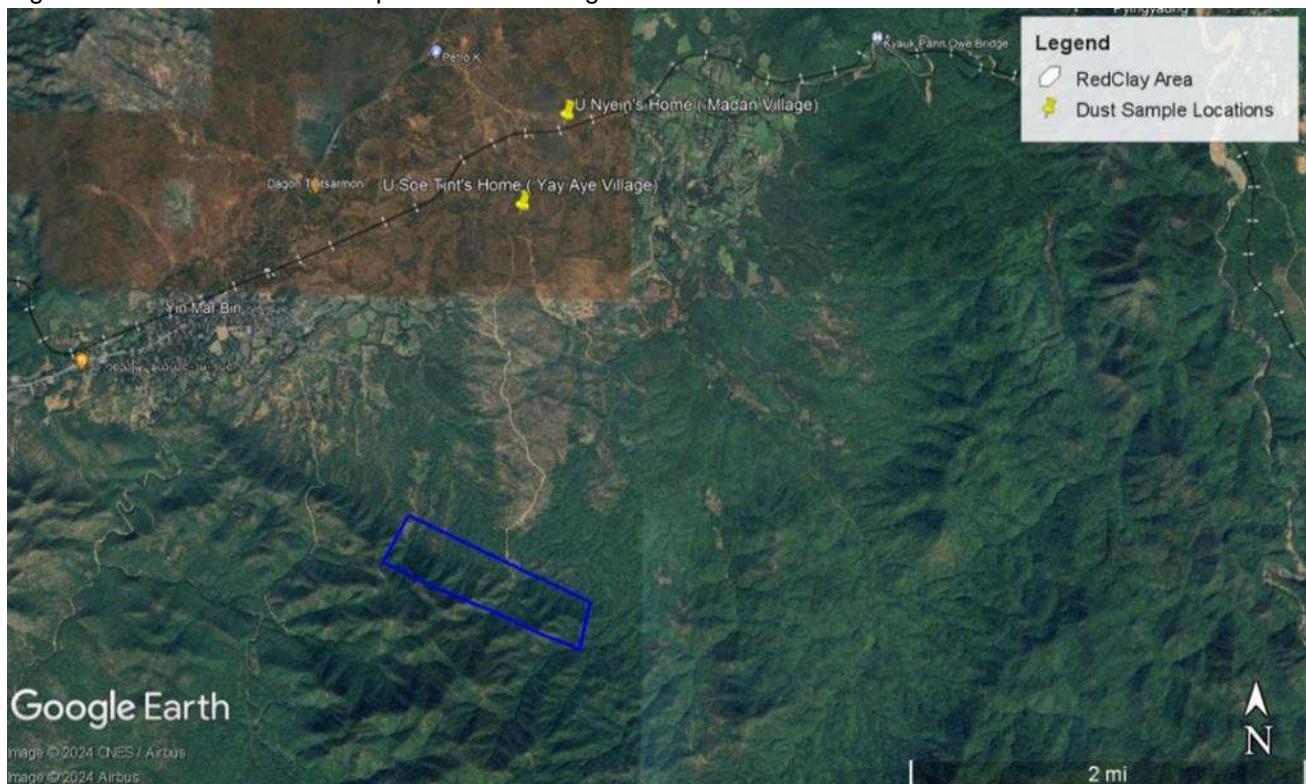
Figure – 2: Location of Dust Deposition Monitoring

STM conducted the monthly monitoring for dust deposition near the red clay area. Figure 2 show the location of monthly Dust Monitoring near the red clay area.

No	Monitoring Location	Latitude	Longitude
1	Madan Village (U Nyein's Home)	20°46'21.02"N	96°20'39.51"E
2	Yay Aye Village (U Soe Tint's Home)	20°45'56.50"N	96°20'26.86"E

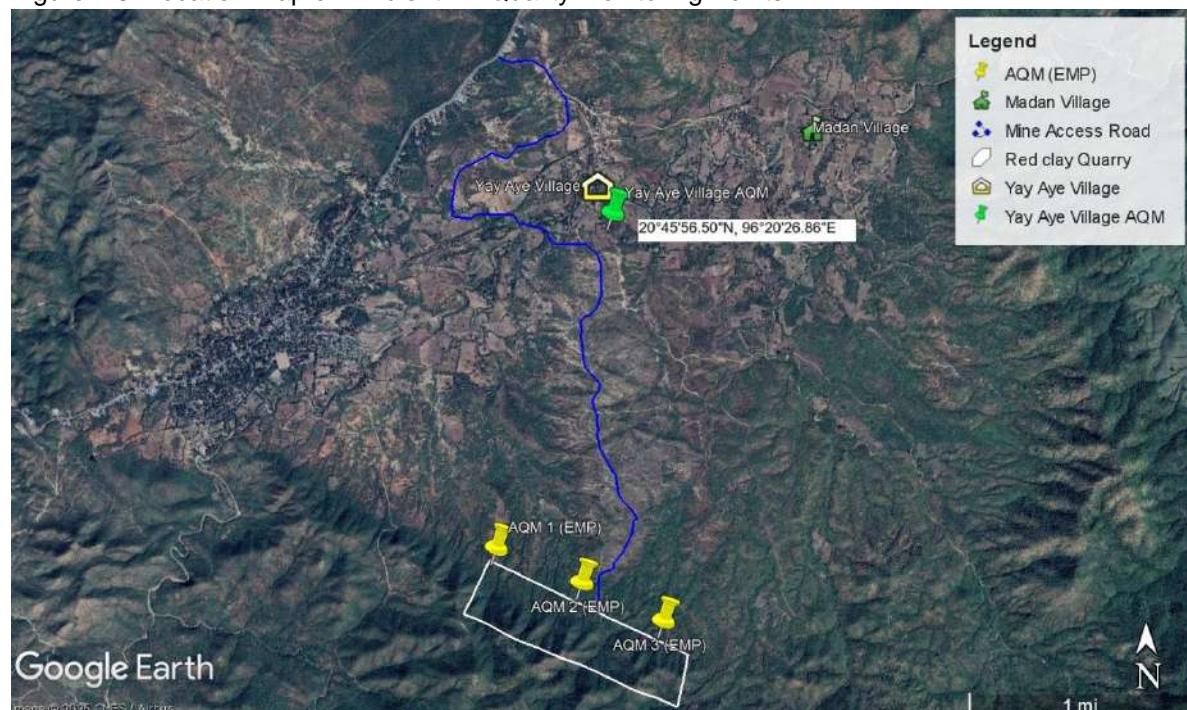
Figure – 3: Location Map of Ambient Air Quality Monitoring Points

The Environmental Management Plan (EMP) for the Red Clay Quarry includes air quality monitoring at three sampling points within the quarry to assess occupational health risks and at a surrounding village to evaluate potential community health impacts. As extraction activities have not yet commenced, HSE Department has been conducting air quality monitoring only at Yay Aye Village, the nearest location to potential receptors that could be affected. STM plans to expand monitoring to one of the designated locations within the quarry site, as specified in the EMP, once extraction activities commence. Figure 3 illustrates the monitoring locations for ambient air quality.

The ambient air monitoring results indicate that while most parameters remained within guideline values, PM_{10} and SO_2 frequently exceeded their respective limits during the dry season months. PM_{10} levels peaked in February and March, primarily due to dry weather conditions, unpaved road traffic, and wind-blown dust, which are typical during the pre-monsoon period. Similarly, SO_2 concentrations surpassed the limit in March, April, and June, likely influenced by increased combustion sources such as forest fire or waste burning in the area. These exceedances highlight the need for seasonal dust suppression measures and stricter control of burning activities to maintain air quality within acceptable standards.

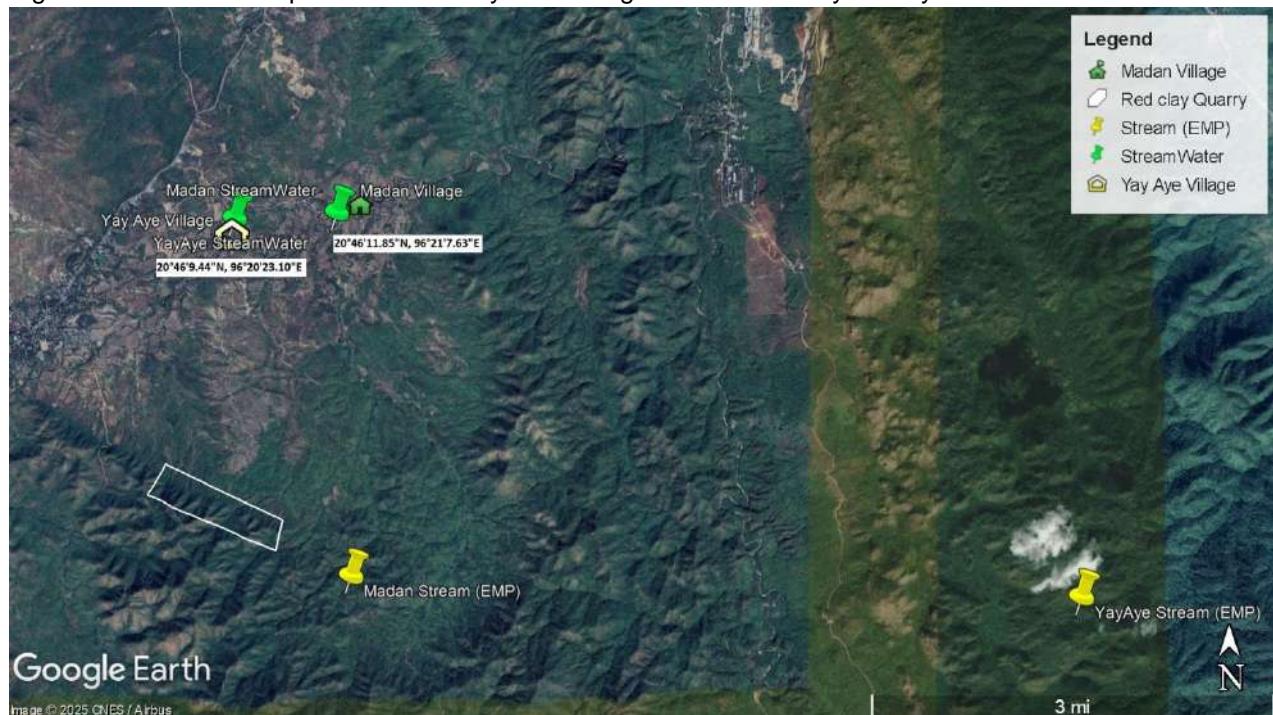
Figure – 4: Location Map of Water Quality Monitoring Around Red Clay Quarry

Monthly monitoring is conducted at these sites for baseline data collection. Parameters measured include pH, color, turbidity, calcium hardness, chloride (Cl), sulfate, total suspended solids (TSS), and nitrate, in accordance with WHO Drinking Water Guidelines and IFC Effluent Water Guidelines. Figure 4 compares the original EMP locations with the current monitoring sites. STM will commence monitoring of sedimentation ponds and general operation water ponds once extraction activities begin.

No	Location		Latitude	Longitude
1	Monitoring Locations in EMP	Yay Aye Stream Water in EMP	20°43'38.31"N	96°19'26.45"E
2		Madan Stream Water in EMP	20°43'44.46"N	96°21'14.97"E
3	Actual Monitoring Locations	Yay Aye Village (Tagondaing Stream)	20°46'9.44"N	96°20'23.10"E
4		Madan Village (Tagondaing Stream)	20°46'11.85"N	96°21'7.63"E

Due to the limitations of STM's laboratory, it was not possible to analyze the full set of water quality parameters specified in the Environmental Management Plan (EMP). However, STM has been conducting monthly analyses of basic water quality parameters. The consistently high color, turbidity, and TSS values are likely due to seasonal rainfall and surface runoff, which cause soil erosion and sediment inflow. To ensure comprehensive assessment and compliance with the EMP, STM has sent Yay Aye and Madan Stream water samples to an external laboratory for full parameter analysis and the results are attached in Appendix-C3 and C4.

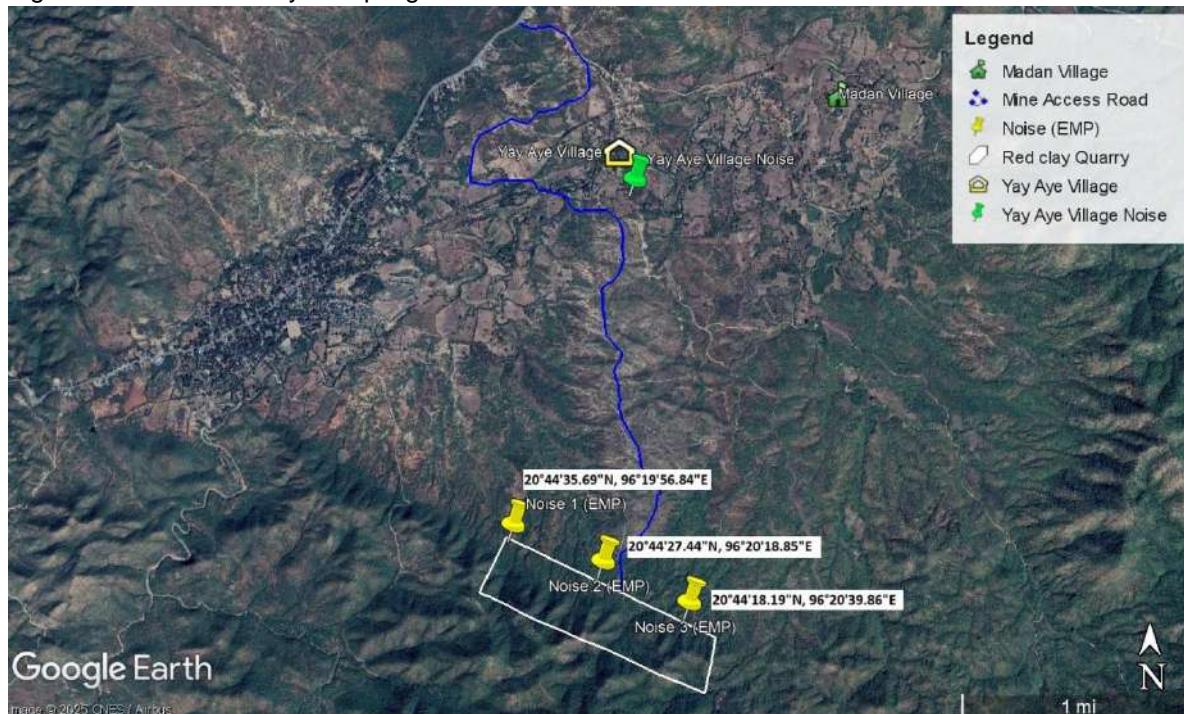
Figure – 5: Noise Quality Sampling Points

The Environmental Management Plan (EMP) for the Red Clay Quarry includes noise monitoring at three sampling points within the quarry to assess occupational health risks and at a surrounding village to evaluate potential community health impacts. As extraction activities have not yet commenced, STM has been conducting noise monitoring within the quarry site, as specified in the EMP. Figure 5 illustrates the monitoring locations for noise.

No.	Monitoring Location	Latitude	Longitude
1	Noise 1 in EMP	20°44'35.69"N	96°19'56.84"E
2	Noise 2 in EMP	20°44'27.44"N	96°20'18.85"E
3	Noise 3 in EMP	20°44'18.19"N	96°20'39.86"E

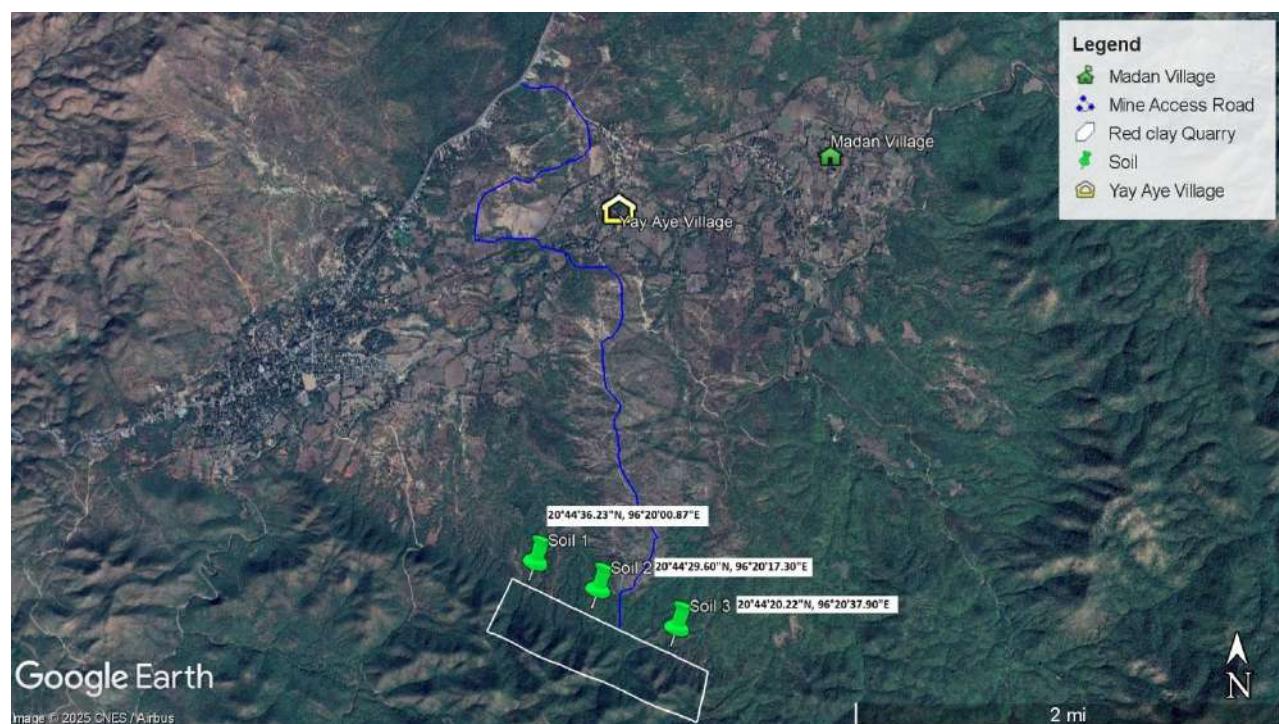
Figure – 6: Location of Soil Quality Monitoring

No.	Monitoring Location			Latitude	Longitude
1	Monitoring Locations in EMP	Soil Quality Monitoring 1 in EMP		20°44'36.23"N	96°20'00.87"E
2		Soil Quality Monitoring 2 in EMP		20°44'29.60"N	96°20'17.30"E
3		Soil Quality Monitoring 3 in EMP		20°44'20.22"N	96°20'37.90"E

The test results from three soil samples indicate notable changes in both mineral content and heavy metal concentrations compared to baseline values. The SiO_2 content increased significantly across all samples, suggesting a higher proportion of silicate minerals, while Fe_2O_3 and Al_2O_3 contents decreased, possibly due to differences in mineral composition. Moisture content, recorded for the first time, ranged from 10.15% to 11.05%, reflecting typical soil conditions. Importantly, the concentrations of heavy metals—copper (Cu), lead (Pb), and zinc (Zn)—were substantially lower in the test results than in baseline levels. According to international standards, such as those provided by the Food and Agriculture Organization (FAO) Soil Bulletin 65 & Dutch Standard, these concentrations are well within the Maximum Permissible Limits (MPL) for agricultural soils, indicating no immediate risk of heavy metal contamination. These findings suggest that the current soil conditions are environmentally stable and suitable for agricultural or reclamation purposes.

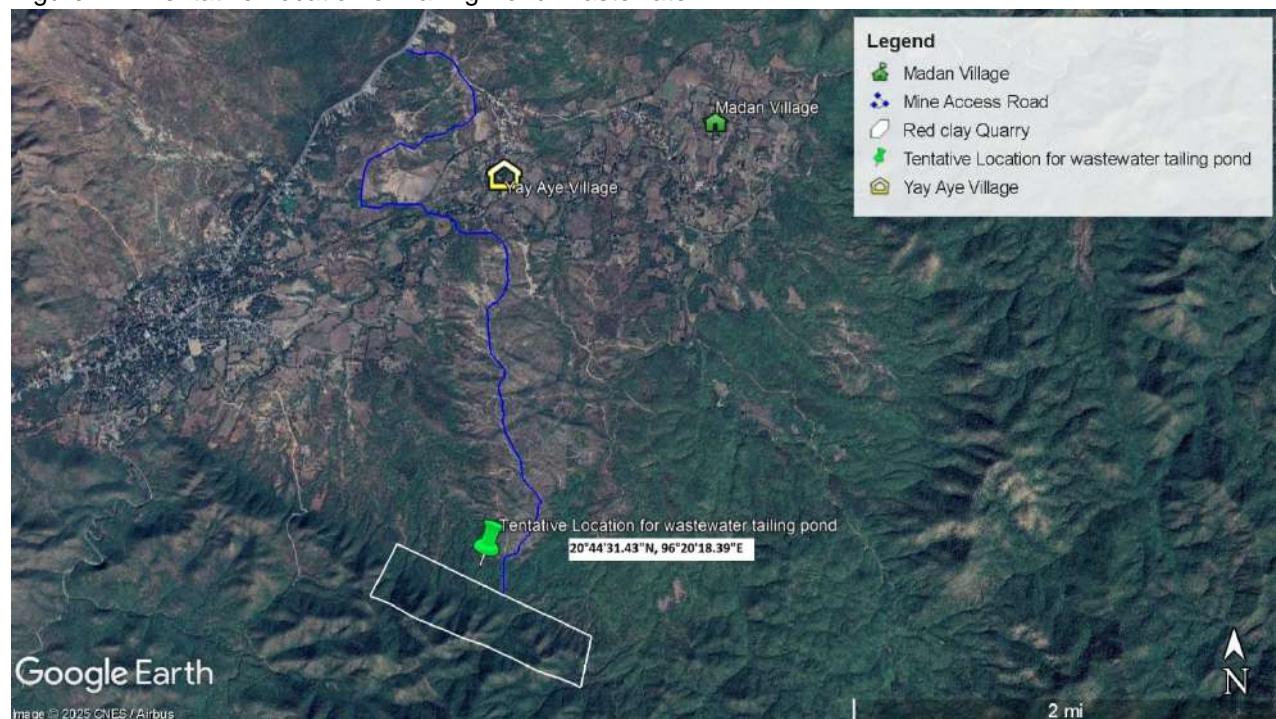
Figure – 7: Tentative Location of Tailing Pond Wastewater

The Environmental Management Plan (EMP) for the Red Clay Quarry includes biannual wastewater quality monitoring at one designated sampling point within the quarry. However, as extraction activities have not yet commenced, STM has not yet conducted wastewater quality monitoring. To ensure a comprehensive assessment and compliance with the EMP, **STM plans to initiate wastewater quality monitoring once the extraction activities begin**. Figure 7 illustrates the tentative monitoring location for wastewater quality.

No.	Monitoring Location	Latitude	Longitude
1	Monitoring Locations in EMP	Wastewater Quality Monitoring 1 in EMP	20°44'31.43"N 96°20'18.39"E

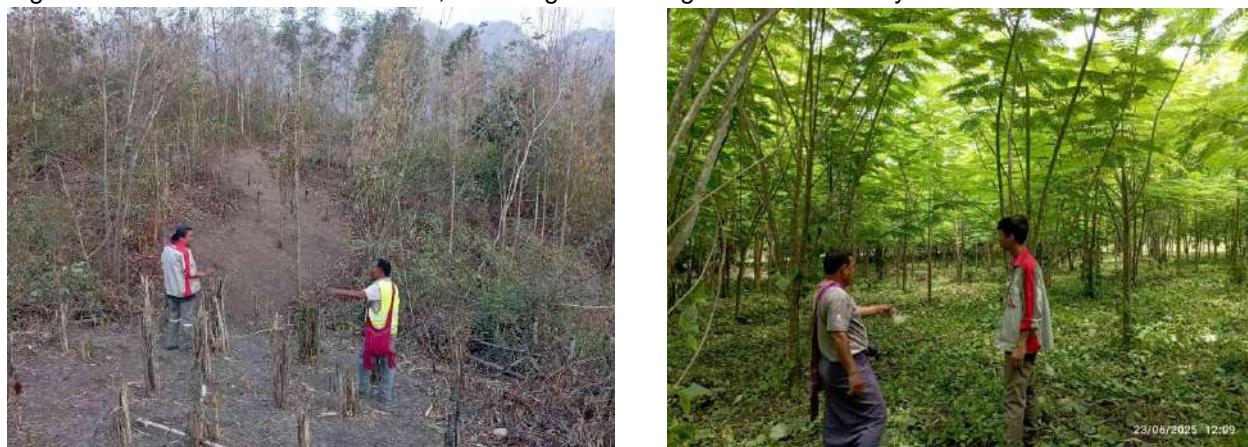
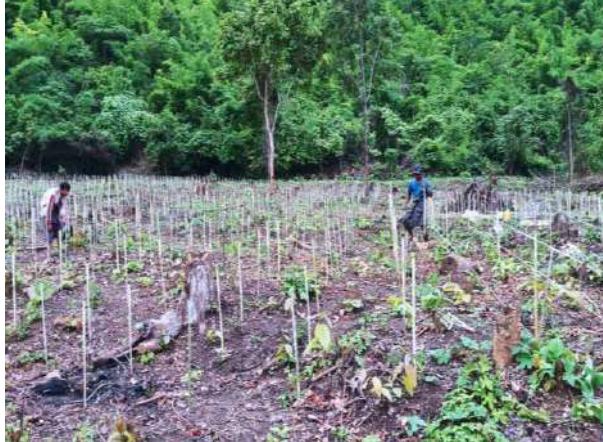
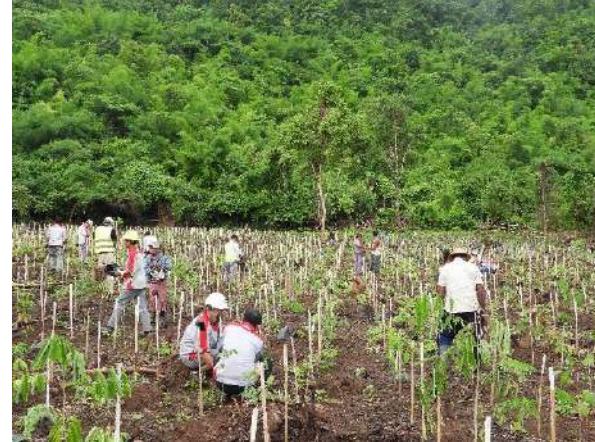
Figure – 8: Record of Fire Protection, Weeding & Patching Process in Ecosystem Restoration Plantation

It is essential to re-cultivate plant and animal species to prevent their loss due to operations within and around the quarry area. Efforts have been made to restore natural vegetation that was displaced during mine operations. Replanting activities have been undertaken to replace the lost vegetation and support the restoration of the local ecosystem.

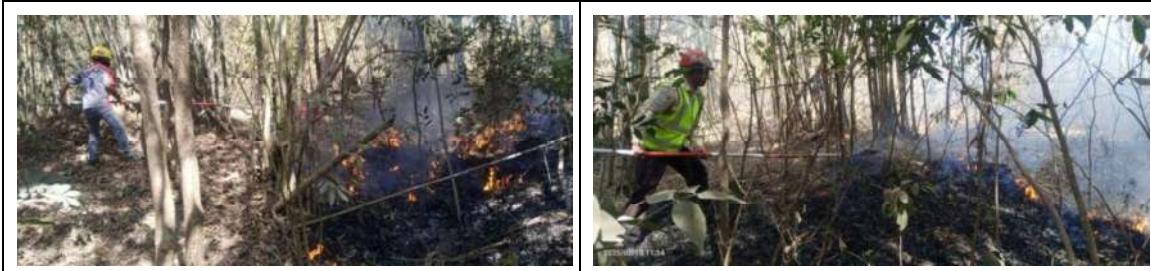
c. Try to mitigate wildfire used by fire hook

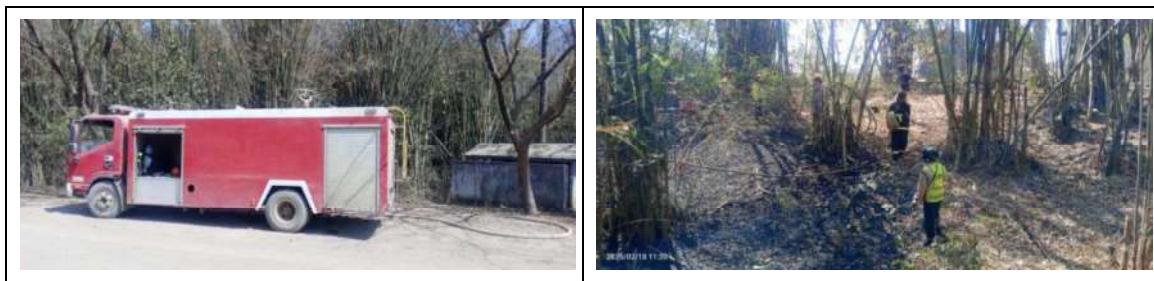
d. Fire truck arrived wildfire location and preparing of firefighting accessories

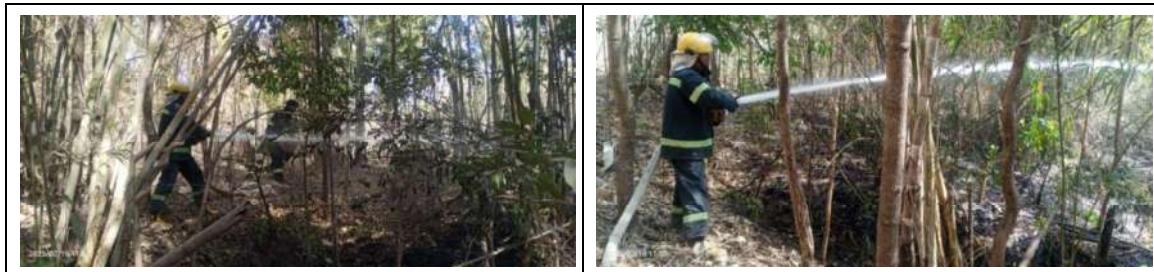
e. Firefighting team extinguished wildfire by using fire truck
