SHWE TAUNG CEMENT COMPANY LIMITED

Bi-Annual Environmental Monitoring Report

Biannual Environmental Monitoring Report **(22 May 2025 to 22 November 2025)**

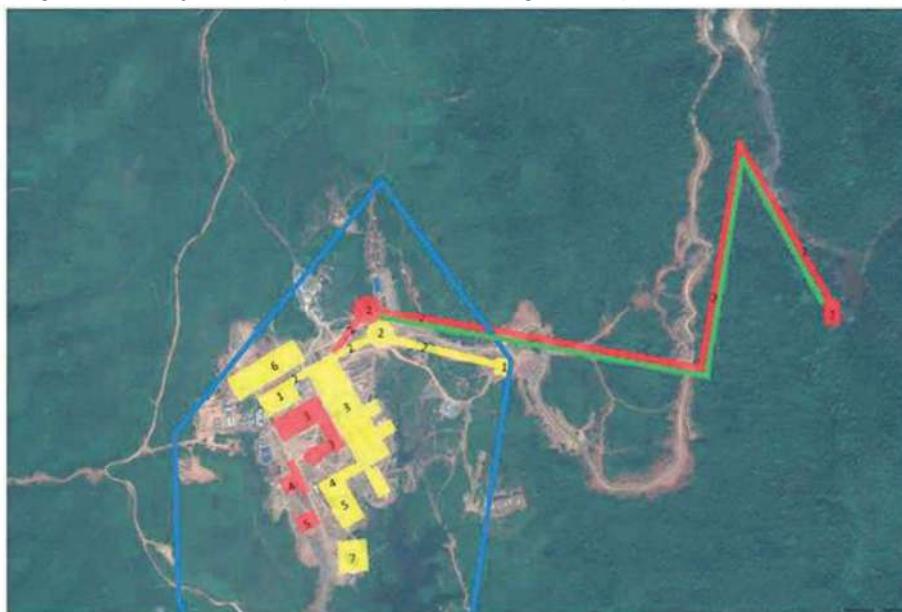
Figure – 2: Project Components of the Existing and Expanded STC Cement Plant

Existing Cement Line Facilities		Expansion Cement Line
1	- Raw Materials Crushing Area	1	- Raw Material Crushing Area
2	- Handling Area	2	- Handling Area
3	- Clinker Production Area	3	- Clinker Production Area
4	- Cement Grinding Area	4	- Cement Grinding Area
5	- Cement Packing and Dispatch Area	5	- Cement Packing and Dispatch Area
6	- Coal Staging Area		
7	- Office

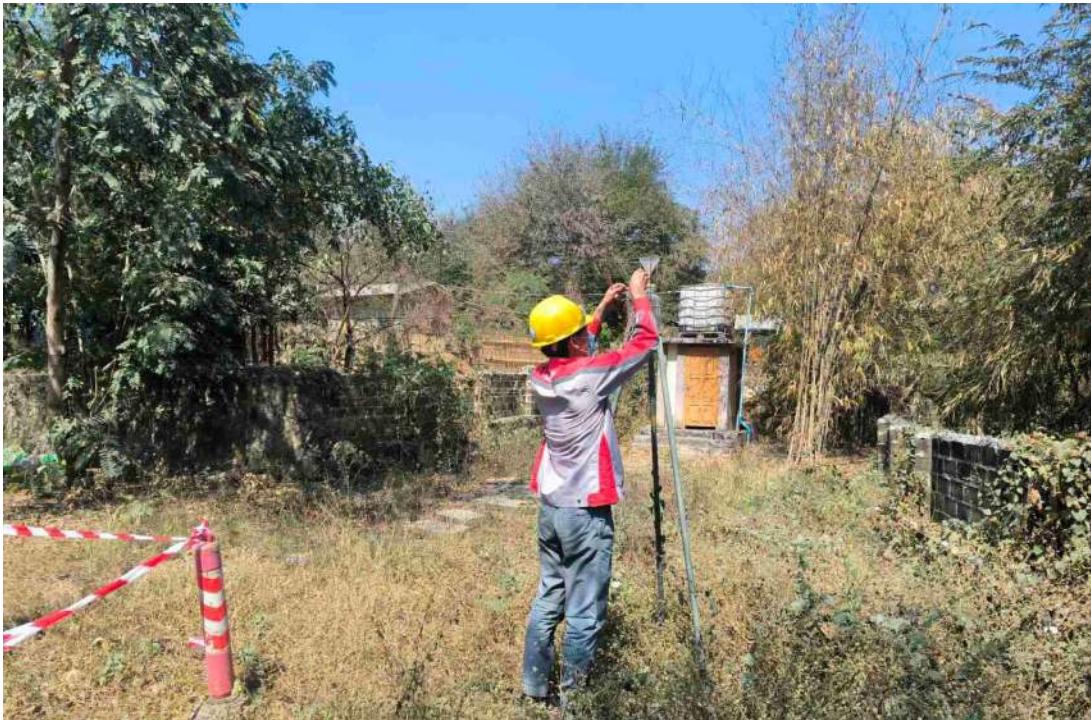
Figure – 6: Dust Deposition Monitoring

STC monitored dust deposition with 15 points at cement plant and limestone quarry, cement plant housing/ accommodation area, Ku Pyin and Pyi Nyaung village. The use of fabric/bag filter system and electrostatic precipitator to collect and control fine suspended particulate emissions are implemented in both lines of cement plant. Water suppression was also undertaken on the roads by using the water from sedimentation ponds to mitigate dust emission on surrounding area in plant site, quarries and plant accommodation area.

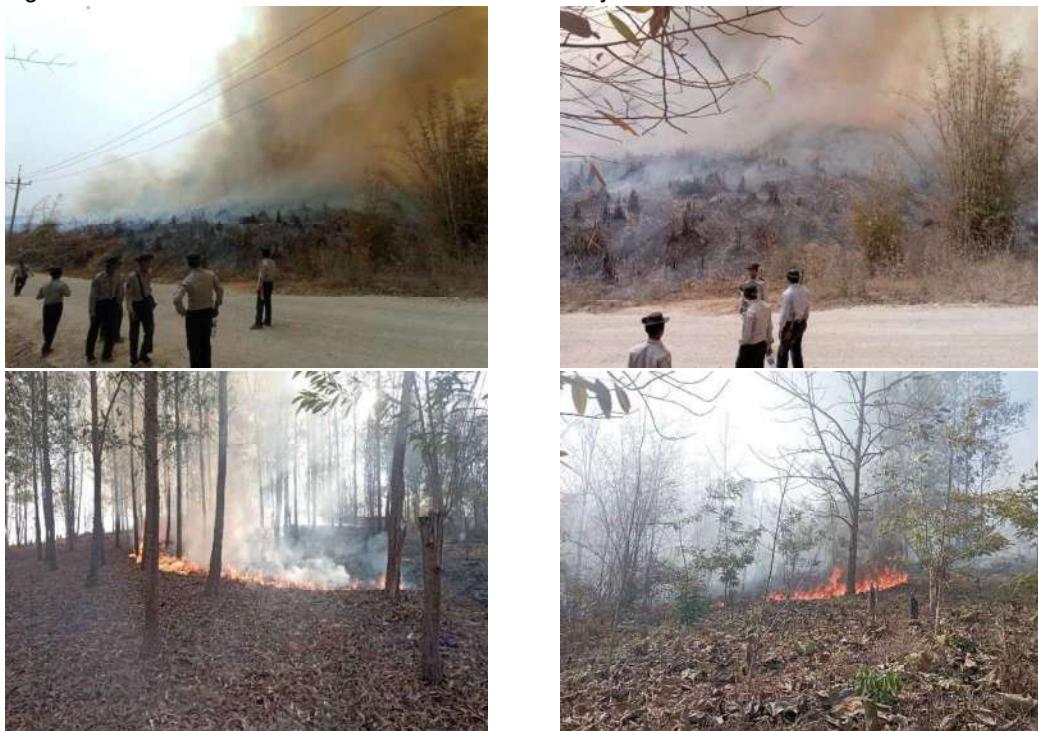
Figure – 7: Forest Fire affected the Ambient Air Quality around STC Cement Plant

STC has investigated the reason of SO_2 result more than Myanmar National Environmental Quality (Emission) Guidelines (2015) as STC uses the low Sulphur content in coal that used as fuel for cement production as stated in STC Cement Plant EIA report. STC has analyzed the monitoring results from the portable HAZ-SCANNER™ EPAS device and found out that SO_2 results were a lot higher during day time and less value at night time. This indicate that the plant is operating 24hours and it couldn't be less during night time.

By analyzing all the AQI results, it is noted that $PM_{2.5}$ values are majorly impacted by human activities (forest firing & open burning, etc.) from surrounding environment. STC will raise the public

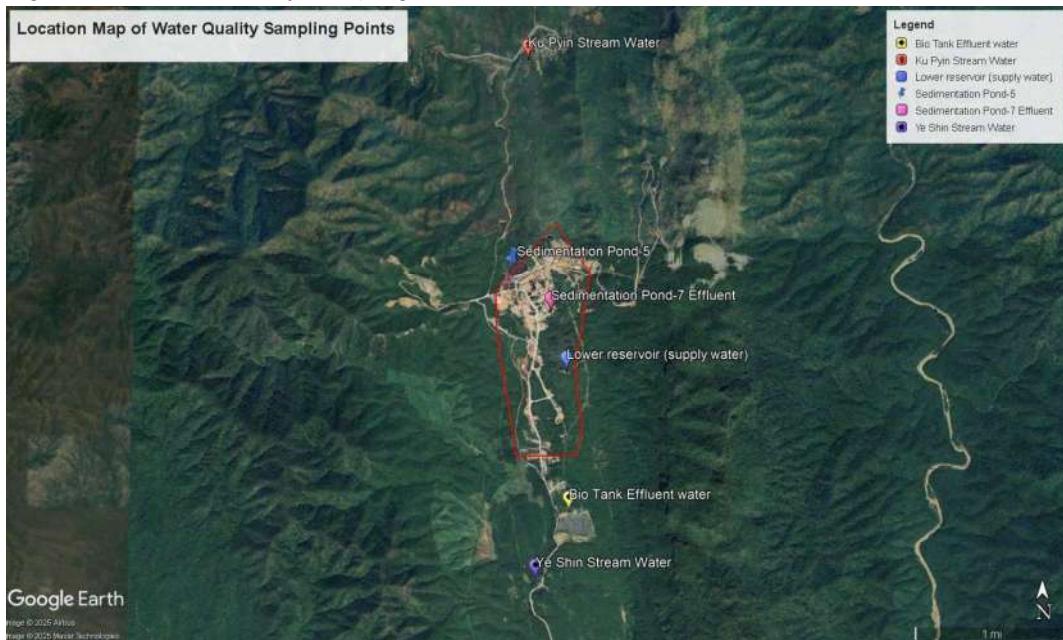
Figure – 10: Water Quality Sampling Points

Monitoring of water quality regularly is quite necessary for the assessment of water quality for beneficial purposes. Operation is dry process and do not generate wastewater. Sanitary wastewater from office and household are discharged to bio tank and treated wastewater are monitored in compliance with the NEQEG on BOD, COD, pH, SS, oil & grease, TN & TP and as per WHO Drinking water guidelines.

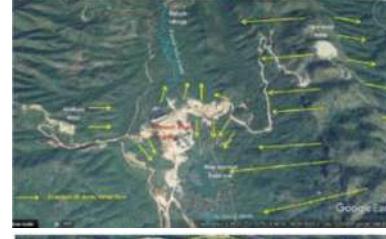
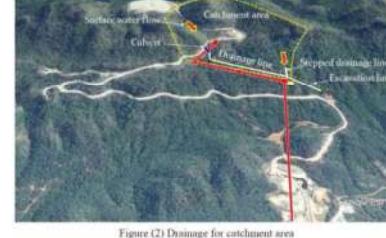
<p>Figure (2) Drainage for catchment area</p>
	<ul style="list-style-type: none"> Divert runoff from the mudstone quarry to an appropriately sized and maintained sedimentation pond to allow adequate retention time for suspended solids to settle; 	Constructed sedimentation pond dual stage.

Affected Aspect	Mitigation Measures	Action Taken	Photos
Surface Water Quality	<ul style="list-style-type: none"> Implementing storm water management practices to manage the flow of storm-water, prevent uncontrolled migration and minimize erosion and sediment transport from project facilities and disturbed areas. Construction of a dedicated drainage network to intercept and diversion runoff; 	Constructed stormwater drains around the cement plant channel to sedimentation ponds

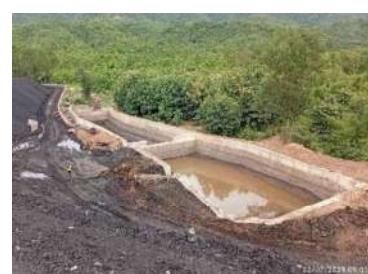
<ul style="list-style-type: none"> For the coal storage area, STM has agreed to cover this area. Water from the roof will be diverted via storm water drains to retention ponds and may be used for greening, dust suppression or discharged to the onsite reservoir. Runoff collected by the interceptor drains (small volume) within the covered coal storage area will be diverted for treatment at the wastewater treatment plant. 	Upgraded sedimentation pond near coal storage area.

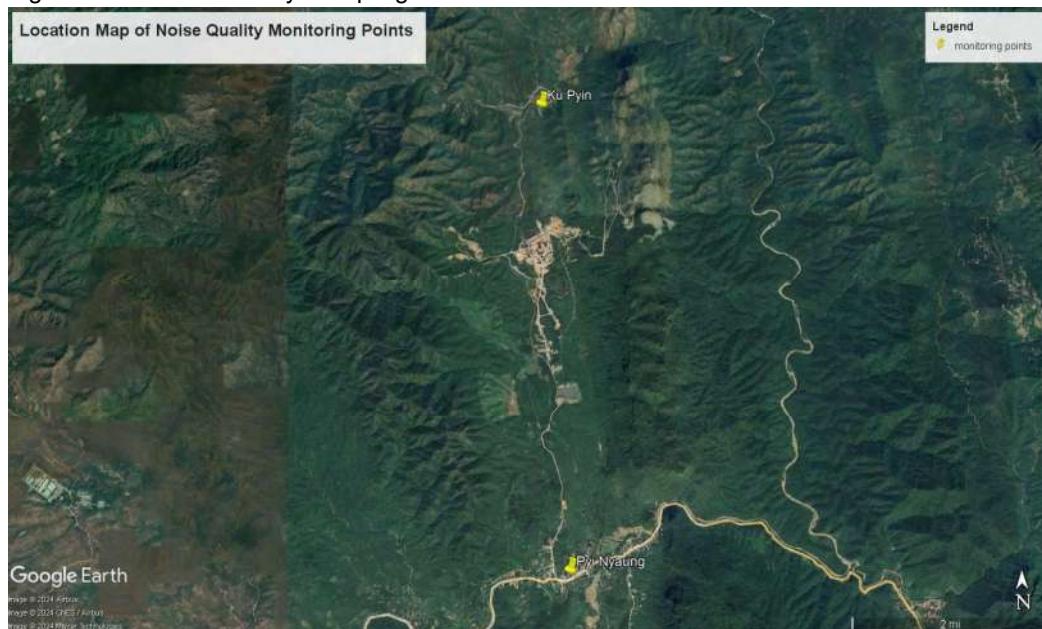
Figure – 11: Noise Quality Sampling Points

No	Noise Monitoring Location	Latitude	Longitude
1	Ku Pyin Village	20°53'20.47"N	96°23'27.58"E
2	Pyi Nyaung Village	20°49'4.58"N	96°23'40.42"E
3	Worker Accommodation	20°50'56.15"N	96°23'35.97"E

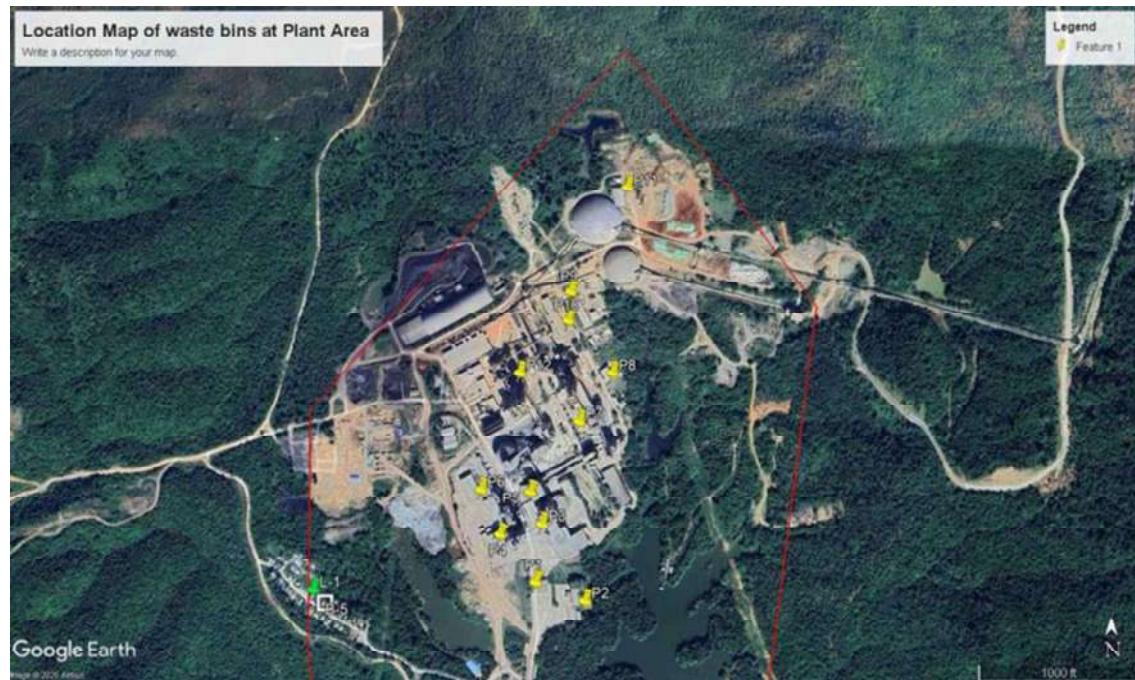
Figure – 12: Location Map of Collection Points of All Generated Wastes from Plant Site

In Shwe Taung Cement Factory, collect non-hazardous waste generated from plant site and accommodation area every day and dispose them to Temporary Non-hazardous Storage Area. For kitchen wastes, compost or use as animal feed in nearby villages. On the other hand, dispose laboratory and clinical wastes to Meikhtila Incinerator, Meikhtila District, Mandalay Region, approved by Meikhtila City Development Committee and have plan to dispose hazardous wastes to Golden Dowa Eco-system Myanmar Co., Ltd., Accredited Waste Management Company. Figure 12, 13 and 14 shows location maps of waste disposal area and waste collection points.

Affected Aspect	Mitigation Measures	Action Taken	Photos
Waste Management	<p>A waste management plan (WMP) for the project has been developed that include the following as a minimum:</p> <ul style="list-style-type: none"> • A waste inventory should be created to establish the types of wastes; 	Approved waste management plan	
	<ul style="list-style-type: none"> • Identify disposal routes (including transport options and disposal sites) for all wastes generated; 	Established (dispose Non-hazardous waste to Temporary N-H Solid Waste Storage area whereas Hazardous waste will be disposed to DOWA, accredited waste management company. Clinical and Laboratory waste are disposed to Meikhtila Incinerator, approved for disposal by Meikhtila City Development Committee)	
	<ul style="list-style-type: none"> • Segregate wastes and recycle wherever possible; 	Identified waste streams (See Figure-12, 13 & 14 for waste collection point and disposal site)

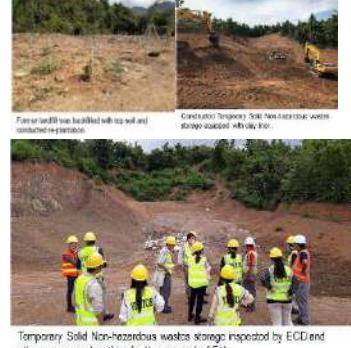
• The existing landfill is not lined and should be only used for inert (non-reactive) and non-hazardous waste only.	Implemented (Constructed Old Temporary Non-hazardous solid storage area for disposing Non-hazardous waste and operated it from 2012 to June 2019. Replantation in old place after closure. After inspection of New Temporary Non-hazardous solid storage area from ECD and governmental organizations in 5 July 2019, operate that one until now.)

Temporary Non-hazardous solid storage area located with top soil and constructed re-plantation. Construction Temporary Non-hazardous solid storage located with clay soil. Temporary Solid Non-hazardous waste storage inspected by ECD and other government entities for the approval of EIA.

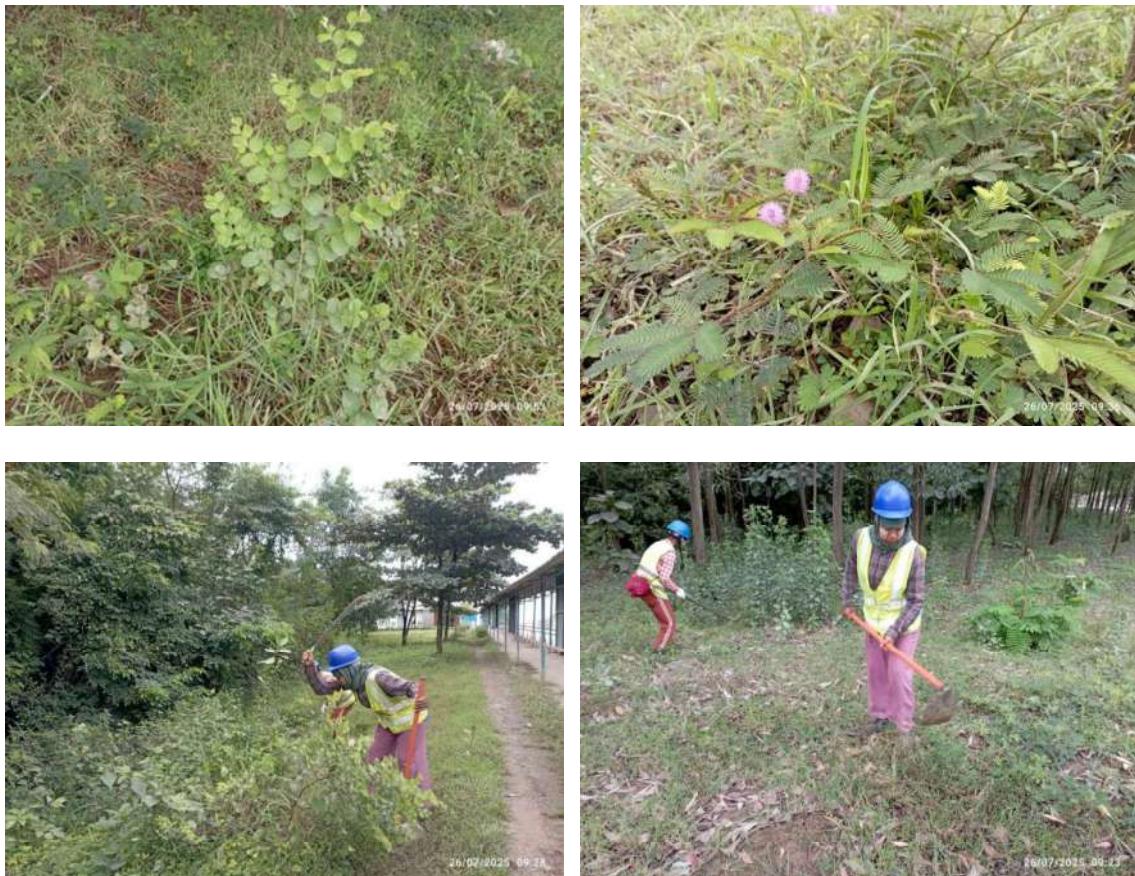
Figure – 17: Photo Records from Invasive Species Survey in July 2025

An invasive flora species survey was conducted within the plant boundary on 26 July 2025. The survey was carried out by walking along established transect lines and recording the occurrence and abundance of invasive plant species. As part of ongoing management measures, clearing and eradication activities were implemented throughout the plant area to prevent the spread of invasive species. During the survey, photographic records were taken for documentation and verification purposes. A total of eight invasive flora species were identified within the surveyed area, namely *Khwe-thay-pan*, *Hmwe-sok*, *Bi-zet*, *Bein-new*, *Baw-za-gaing*, *Hti-ka-yone*, *Kyaung-sha*, and *Zi*.

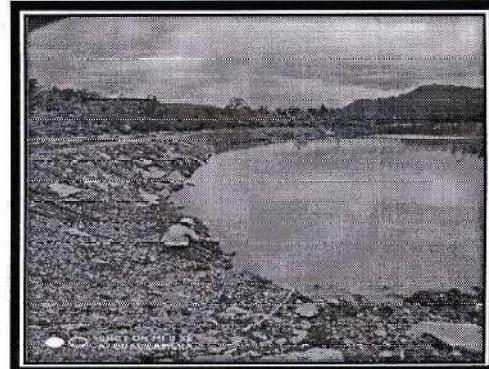
Nature of water Surface Water
Location Beside 103 & 501 Area
Date of sample collection 19.05.2025
Date of sample examination 20.05.2025
Date of completing 21.05.2025

Description of Analysis	Analysis Results	IFC Waste Water Guideline	Remark
pH	7.3	6-9	
Chemical Oxygen Demand(COD)	-	0-125mg/L	no stock chemical
Biological Oxygen Demand(BOD)	-	0-30mg/L	no stock chemical
Total Suspended Solid(TSS)	83	Max 50mg/L	
Total Nitrogen	0.81	10mg/L	
Total Nitrate	3.6	44.29mg/L	
Total Phosphorous	-	2mg/L	no stock chemical

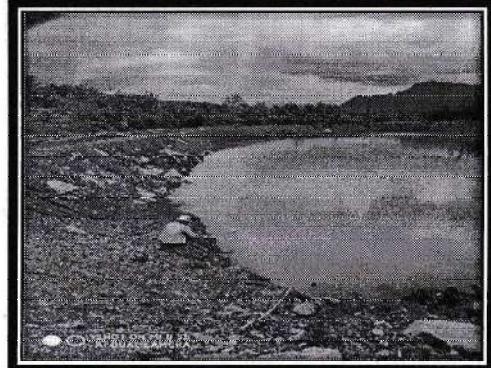
Nature of water Surface Water
Location Beside 103 & 501 Area
Date of sample collection 20.08.2025
Date of sample examination 21.08.2025
Date of completing 22.08.2025

Description of Analysis	Analysis Results	IFC Waste Water Guideline	Remark
pH	7.8	6-9	
Chemical Oxygen Demand(COD)	-	0-125mg/L	no stock chemical
Biologycal Oxygen Demand(BOD)	-	0-30mg/L	no stock chemical
Total Suspended Solid(TSS)	46	Max 50mg/L	
Total Nitrogen	-	10mg/L	no stock chemical
Total Nitrate	-	44.29mg/L	no stock chemical
Total Phosphorous	-	2mg/L	no stock chemical

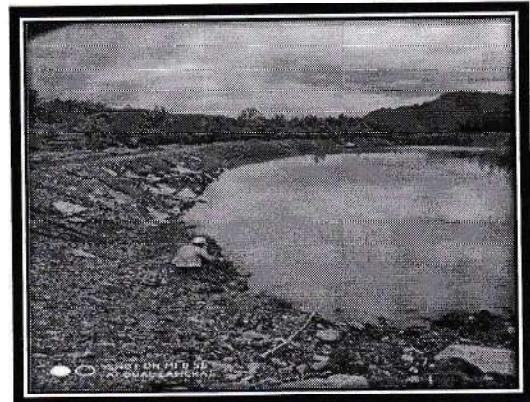
Nature of water Surface Water
Location Beside 103 & 501 Area
Date of sample collection 18.09.2025
Date of sample examination 19.09.2025
Date of completing 20.09.2025

Description of Analysis	Analysis Results	IFC Waste Water Guideline	Remark
pH	7.8	6-9	
Chemical Oxygen Demand(COD)	-	0-125mg/L	no stock chemical
Biological Oxygen Demand(BOD)	-	0-30mg/L	no stock chemical
Total Suspended Solid(TSS)	83	Max 50mg/L	
Total Nitrogen	-	10mg/L	no stock chemical
Total Nitrate	-	44.29mg/L	no stock chemical
Total Phosphorous	-	2mg/L	no stock chemical

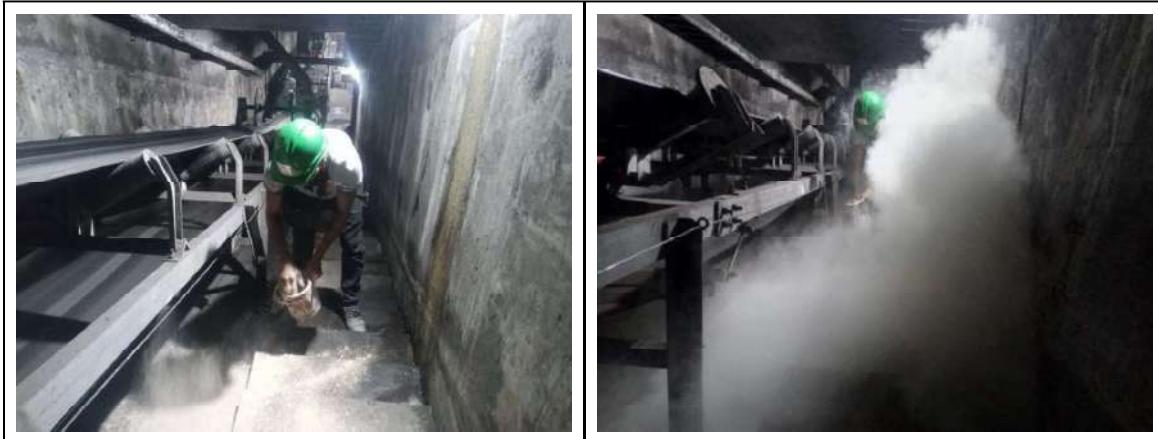
- c. CPP site operator try to extinguish coal smoldering using by raw meal

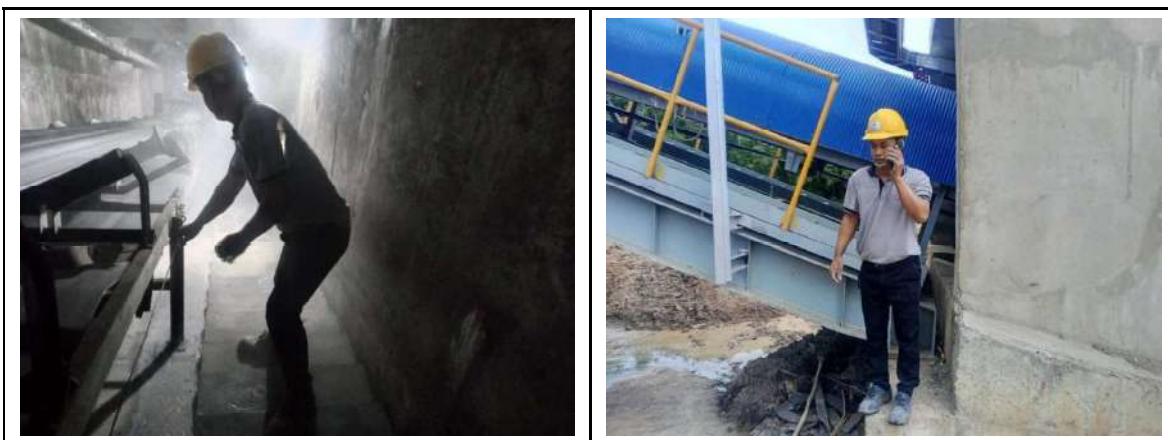
- d. Site supervisor stop belt conveyor using pull cord and inform to emergency hot line

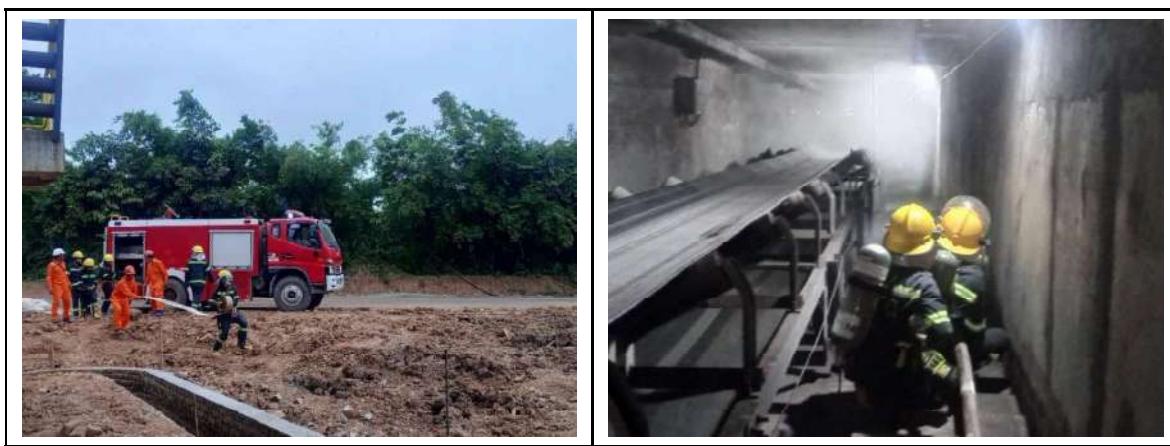
- h. firefighting team extinguished fire

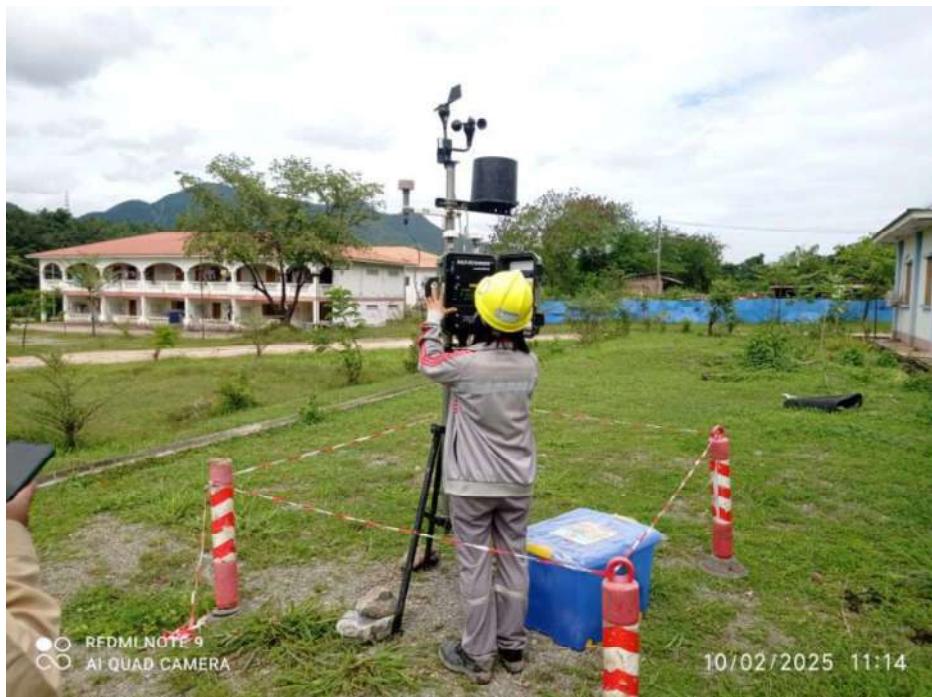
Worker Accommodation

Ambient Air Monitoring Photo Records

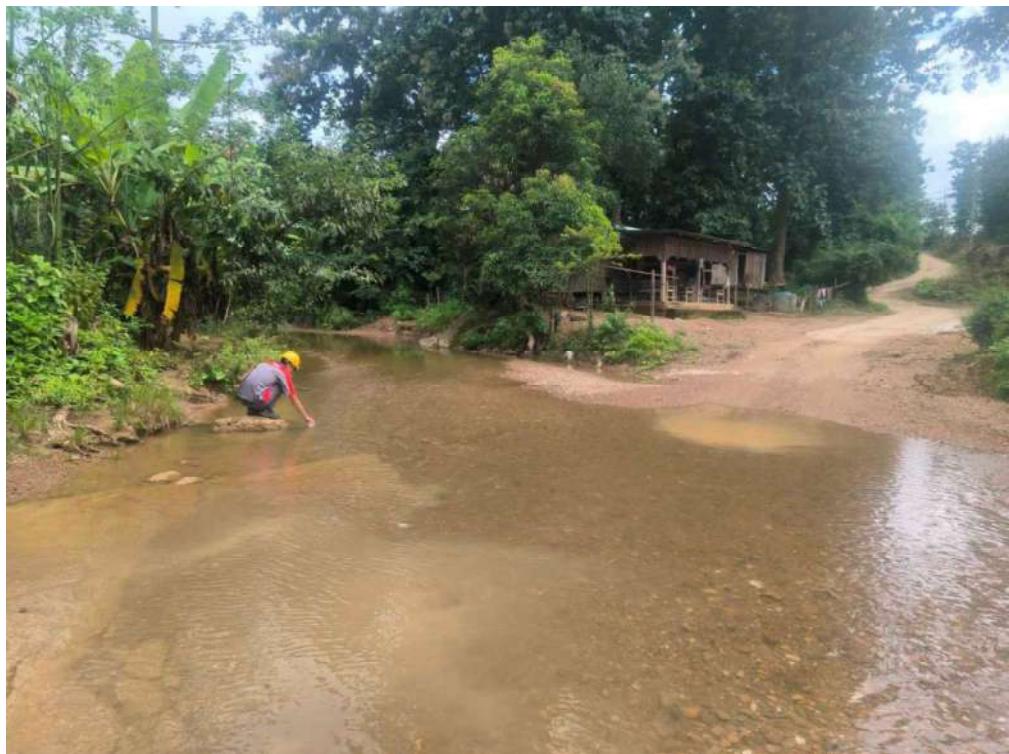
Ku Pyin Stream

Water Quality Monitoring Photo Records

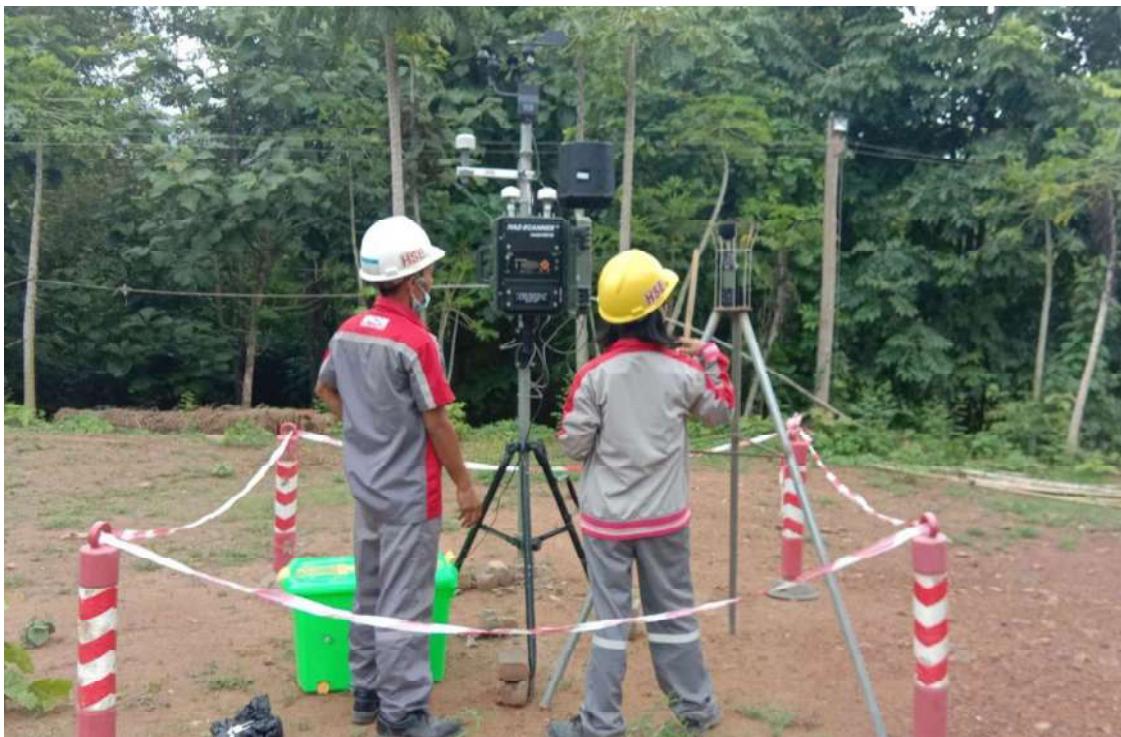
Ku Pyin Village

Noise Monitoring Photo Record
